Access Compliance Report

Public Rights-of-Way

(Curb Ramps)

Intersection ID: 3132	Main Street: BASKERVILLE_AV	Cross Street: LENOX_HILL_PL	Location: E
ADA ID: 4CDB77FDB8AE	Ramp Type: Perp	Initial Pass/Fail: Fail	Overall Compliance: No
		Severity Score: 12.5

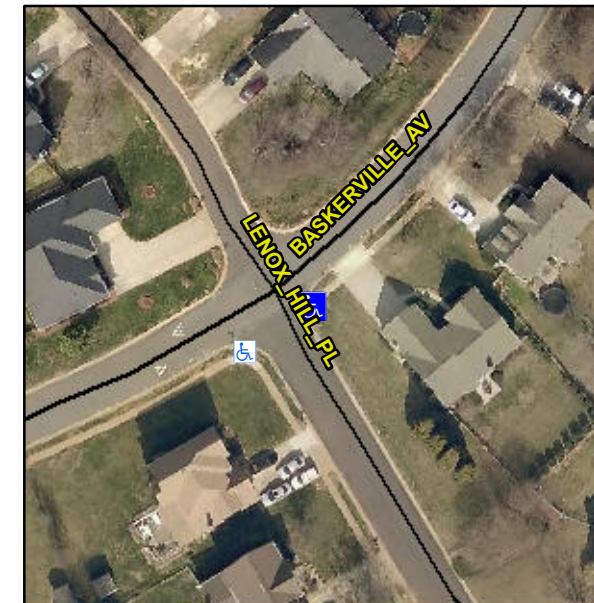
Not Found, R304.2.2

Compliance	Description	Data	Compliance	Description	Data
N/A	Ramp Length (in)	49.0	No	Ramp Slope (%)	8.4
Yes	Ramp Width (in)	78.0	Yes	Ramp XSlope (%)	0.9
N/A	Flare Type LT	N/A	N/A	Flare Type RT	N/A
N/A	Flare Slope LT (%)	N/A	N/A	Flare Slope RT (%)	N/A
N/A	Flare Traversable LT?	N/A	N/A	Flare Traversable RT?	N/A
N/A	Landing Length (in)	N/A	N/A	DWS Provided?	N/A
N/A	Landing Width (in)	N/A	N/A	DWS Contrast?	N/A
N/A	Landing Slope (%)	N/A	N/A	DWS Length (in)	N/A
N/A	Landing X Slope (%)	N/A	N/A	DWS Full Width?	N/A
N/A	Landing Curb? (Y/N)	N/A	N/A	DWS Offset (in)	N/A
N/A	Shared Landing?	N/A			
N/A	Gutter Ponding?	N/A	N/A	Gutter Slope (%)	N/A
N/A	Gutter Lip Ht (in)	N/A	N/A	Gutter X Slope (%)	N/A
N/A	Painted X Walk1?	No	N/A	Painted X Walk2?	N/A
	X Walk 1 Direction	To SW		X Walk 2 Direction	N/A
N/A	X Walk 1 Width (in)	N/A	N/A	X Walk 2 Width (in)	N/A
	X Walk 1 Slope (%)	2.1		X Walk 2 Slope (%)	N/A
	X Walk 1 X Slope (%)	0.6		X Walk 2 X Slope (%)	N/A

N/A	Ramp inside XWalk1?	N/A	N/A	Ramp inside XWalk2?	N/A
	Road Slope (%)	N/A	N/A	Clear Space?	N/A
	Road X Slope (%)	N/A	N/A	Clear Space to XWalk (in)	N/A
N/A	Any Obstructions?	N/A	N/A	Storm Grate/Utility Hazard?	N/A
	Obstruction Type			Storm Grate/Utility Type	
		N/A			N/A
			Yes	Surface Condition? (G/P)	Good

Remove & Replace Entire Ramp.
