Access Compliance Report

Public Rights-of-Way

(Curb Ramps)

Intersection ID: 9325	Main Street: FREEDOM_DR	Cross Street: MARLENE_ST	Location: NW
ADA ID: 4CF0FEFCC130	Ramp Type: Perp	Initial Pass/Fail: Fail	Overall Compliance: No
Severity Score: 10			
Codes/Mitigation Info/Possible Solution		Field Measurements/Component Compliance

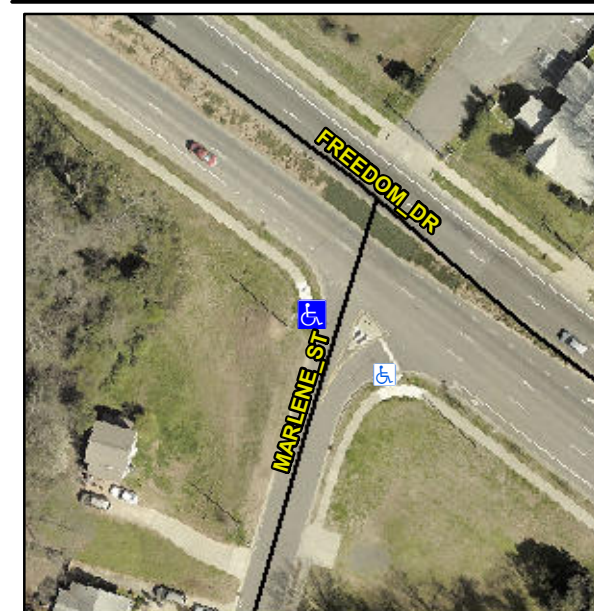
Not Found, R304.5.1, R304.5.3

Compliance	Description	Data	Compliance	Description	Data
N/A	Ramp Length (in)	59.0	Yes	Ramp Slope (%)	5.8
No	Ramp Width (in)	47.5	No	Ramp XSlope (%)	5.0
N/A	Flare Type LT	N/A	N/A	Flare Type RT	N/A
N/A	Flare Slope LT (%)	N/A	N/A	Flare Slope RT (%)	N/A
N/A	Flare Traversable LT?	N/A	N/A	Flare Traversable RT?	N/A
N/A	Landing Length (in)	N/A	N/A	DWS Provided?	N/A
N/A	Landing Width (in)	N/A	N/A	DWS Contrast?	N/A
N/A	Landing Slope (%)	N/A	N/A	DWS Length (in)	N/A
N/A	Landing X Slope (%)	N/A	N/A	DWS Full Width?	N/A
N/A	Landing Curb? (Y/N)	N/A	N/A	DWS Offset (in)	N/A
N/A	Shared Landing?	N/A			
N/A	Gutter Ponding?	N/A	N/A	Gutter Slope (%)	N/A
N/A	Gutter Lip Ht (in)	0.5	N/A	Gutter X Slope (%)	N/A
N/A	Painted X Walk1?	No	N/A	Painted X Walk2?	N/A
	X Walk 1 Direction	To SE		X Walk 2 Direction	N/A
N/A	X Walk 1 Width (in)	N/A	N/A	X Walk 2 Width (in)	N/A
	X Walk 1 Slope (%)	0.7		X Walk 2 Slope (%)	N/A
	X Walk 1 X Slope (%)	4.4		X Walk 2 X Slope (%)	N/A

N/A	Ramp inside XWalk1?	N/A	N/A	Ramp inside XWalk2?	N/A
	Road Slope (%)	N/A	N/A	Clear Space?	N/A
	Road X Slope (%)	N/A	N/A	Clear Space to XWalk (in)	N/A
N/A	Any Obstructions?	N/A	N/A	Storm Grate/Utility Hazard?	N/A
	Obstruction Type			Storm Grate/Utility Type	
		N/A			N/A
			Yes	Surface Condition? (G/P)	Good

Possible Solutions:

Remove & Replace Entire Ramp.
