Access Compliance Report Public Rights-of-Way (Curb Ramps)

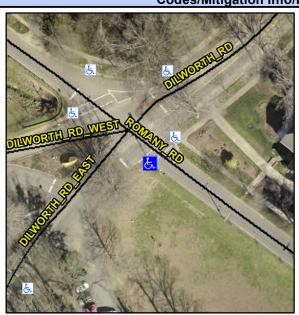
Intersection ID: 14600 Main Street: DILWORTH_RD Cross Street: DILWORTH_RD_EAST Location: SE

ADA ID: 4CF4CEE787B5 Ramp Type: Directional1 Initial Pass/Fail: Fail Overall Compliance: No Severity Score: 25

Surveyor Notes:
STOP SIGN & FLASHING SIGNAL

Total Cost: \$ 1800.00

Possible Solutions:
Remove & Replace Entire Ramp.
Restripe Crosswalk.
