## **Access Compliance Report Public Rights-of-Way** (Curb Ramps)

Intersection ID: 15028 Main Street: CLANTON RD **Cross Street: FIELDCREST RD** Location: NW **ADA ID: 4CF8B9AAFE7D** Ramp Type: ParaDiag Initial Pass/Fail: Fail **Overall Compliance: No Severity Score:** 22.5

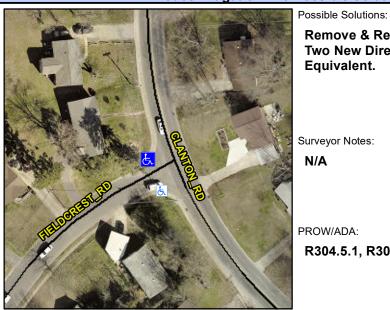
Compliance Description			00	ance	Description	Data
N/A	Ramp Length LT (in)	27.0	N/A	Ramp	Length RT (in)	23.0
No	Ramp Width LT (in)	47.5	No	Ramp	Width RT (in)	46.0
No	Ramp Slope LT (%)	8.7	Yes	Ramp	Slope RT (%)	5.7
No	Ramp XSlope LT (%)	2.3	No	Ramp	XSlope RT (%)	2.6
N/A	Landing Length (in)	N/A	N/A	DWS	Provided?	N/A
N/A	Landing Width (in)	N/A	N/A	DWS	Contrast?	N/A
N/A	Landing Slope (%)	N/A	N/A	DWS	Length (in)	N/A
N/A	Landing X Slope (%)	N/A	N/A	DWS	Full Width?	N/A
N/A	Landing Curb? (Y/N)	N/A	N/A	DWS	Offset (in)	N/A
N/A	Shared Landing?	N/A				
N/A	Gutter Ponding?	N/A	N/A	Gutte	r Slope (%)	N/A
N/A	Gutter Lip Ht (in)	N/A	N/A	Gutte	r X Slope (%)	N/A
N/A	Painted X Walk1?	No	N/A	Painte	ed X Walk2?	No
	X Walk 1 Direction	To S		X Wa	lk 2 Direction	To E
N/A	X Walk 1 Width (in)	N/A	N/A	X Wa	lk 2 Width (in)	N/A
:	X Walk 1 Slope (%)	3.6		X Wa	lk 2 Slope (%)	1.2
	X Walk 1 X Slope (%)	2.9		X Wa	lk 2 X Slope (%)	7.3
N/A	Ramp inside XWalk1?	N/A	N/A	Ramp	inside XWalk2?	N/A

Road Slope (%)	1.2	N/A	Clear	Space?	N/A
	Road X Slope (%)	7.6	N/A	Clear	Space to XWalk (in)	N/A
N/A	Any Obstructions?	N/A	N/A	Storm	Grate/Utility Hazard?	N/A
	Obstruction Type			Storm	n Grate/Utility Type	
		N/A				N/A
			Yes	Surfa	ce Condition? (G/P)	Good
			N/A	Curb	Slope (%)	4.9

Remove & Replace Curb Ramp With Two New Directional Ramps or Equivalent.
