Access Compliance Report

Public Rights-of-Way

(Curb Ramps)

Intersection ID: 15096	Main Street: OLMSTED_PARK_PL	Cross Street: WINTHROP_AV	Location: NW
ADA ID: 4CFF3ACD84AE	Ramp Type: PerpDiag	Initial Pass/Fail: Fail	Overall Compliance: No
Severity Score: 13.75			
Codes/Mitigation Info/Possible Solution		Field Measurements/Component Compliance

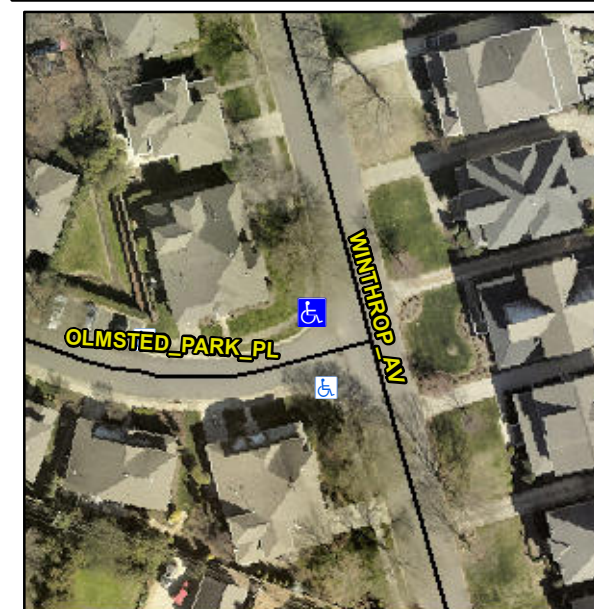
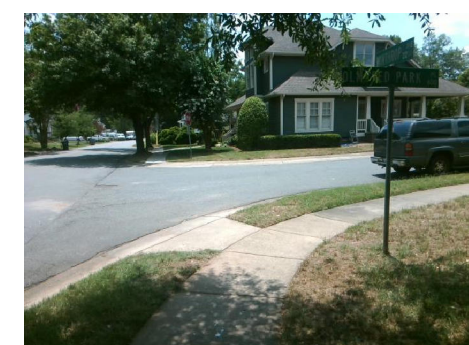
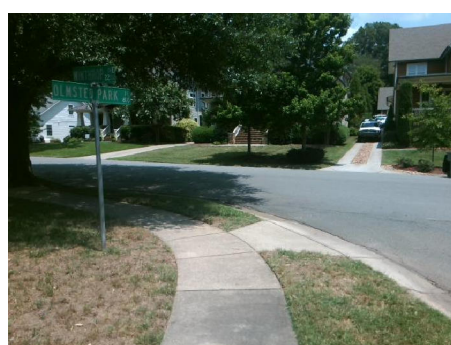
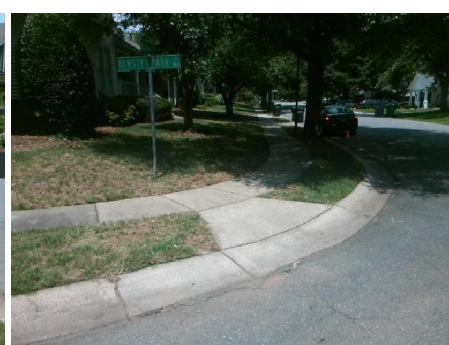
Not Found, R304.2.2, R304.5.3

Compliance	Description	Data	Compliance	Description	Data
N/A	Ramp Length (in)	49.0	No	Ramp Slope (%)	11.1
Yes	Ramp Width (in)	48.0	No	Ramp XSlope (%)	3.5
N/A	Flare Type LT	N/A	N/A	Flare Type RT	N/A
N/A	Flare Slope LT (%)	N/A	N/A	Flare Slope RT (%)	N/A
N/A	Flare Traversable LT?	N/A	N/A	Flare Traversable RT?	N/A
N/A	Landing Length (in)	N/A	N/A	DWS Provided?	N/A
N/A	Landing Width (in)	N/A	N/A	DWS Contrast?	N/A
N/A	Landing Slope (%)	N/A	N/A	DWS Length (in)	N/A
N/A	Landing X Slope (%)	N/A	N/A	DWS Full Width?	N/A
N/A	Landing Curb? (Y/N)	N/A	N/A	DWS Offset (in)	N/A
N/A	Shared Landing?	N/A			
N/A	Gutter Ponding?	N/A	N/A	Gutter Slope (%)	N/A
N/A	Gutter Lip Ht (in)	N/A	N/A	Gutter X Slope (%)	N/A
N/A	Painted X Walk1?	No	N/A	Painted X Walk2?	No
	X Walk 1 Direction	To S		X Walk 2 Direction	To E
N/A	X Walk 1 Width (in)	N/A	N/A	X Walk 2 Width (in)	N/A
	X Walk 1 Slope (%)	1.0		X Walk 2 Slope (%)	0.1
	X Walk 1 X Slope (%)	0.6		X Walk 2 X Slope (%)	2.3

N/A	Ramp inside XWalk1?	N/A	N/A	Ramp inside XWalk2?	N/A
	Road Slope (%)	1.1	N/A	Clear Space?	N/A
	Road X Slope (%)	1.7	N/A	Clear Space to XWalk (in)	N/A
N/A	Any Obstructions?	N/A	N/A	Storm Grate/Utility Hazard?	N/A
	Obstruction Type			Storm Grate/Utility Type	
		N/A			N/A
		Yes		Surface Condition? (G/P)	Good

Remove & Replace Curb Ramp With Two New Directional Ramps or Equivalent.
