Access Compliance Report Public Rights-of-Way (Curb Ramps)

Intersection ID: 14925 Main Street: BROMLEY_RD **Cross Street: QUEENS_RD** Location: SE **Severity Score: Overall Compliance: No** ADA ID: 4D1225AD5F70 Ramp Type: Perp Initial Pass/Fail: Fail 30

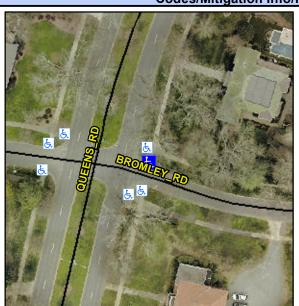
Field Measurements/Component Compliance							
Com	pliance Description	Data	Comp	oliance Description	Data		
N/A	Ramp Length (in)	59.5	No	Ramp Slope (%)	10.7		
No	Ramp Width (in)	33.0	Yes	Ramp XSlope (%)	0.5		
N/A	Flare Type LT	N/A	N/A	Flare Type RT	N/A		
N/A	Flare Slope LT (%)	N/A	N/A	Flare Slope RT (%)	N/A		
N/A	Flare Traversable LT?	N/A	N/A	Flare Traversable RT?	N/A		
N/A	Landing Length (in)	N/A	N/A	DWS Provided?	N/A		
N/A	Landing Width (in)	N/A	N/A	DWS Contrast?	N/A		
N/A	Landing Slope (%)	N/A	N/A	DWS Length (in)	N/A		
N/A	Landing X Slope (%)	N/A	N/A	DWS Full Width?	N/A		
N/A	Landing Curb? (Y/N)	N/A	N/A	DWS Offset (in)	N/A		
N/A	Shared Landing?	N/A					
N/A	Gutter Ponding?	N/A	N/A	Gutter Slope (%)	N/A		
N/A	Gutter Lip Ht (in)	N/A	N/A	Gutter X Slope (%)	N/A		
N/A	Painted X Walk1?	No	N/A	Painted X Walk2?	N/A		
	X Walk 1 Direction	To SW		X Walk 2 Direction	N/A		
N/A	X Walk 1 Width (in)	N/A	N/A	X Walk 2 Width (in)	N/A

X Walk 1 Slope (%)	0.8		X Walk 2 Slope (%)	N/A		
	X Walk 1 X Slope (%)	2.6		X Walk 2 X Slope (%)	N/A		
N/A	Ramp inside XWalk1?	N/A	N/A	Ramp inside XWalk2?	N/A		
	Road Slope (%)	N/A	N/A	Clear Space?	N/A		
	Road X Slope (%)	N/A	N/A	Clear Space to XWalk (in)	N/A		
N/A	Any Obstructions?	N/A	N/A	Storm Grate/Utility Hazard?	N/A		
	Obstruction Type			Storm Grate/Utility Type			
		N/A			N/A		
			Yes	Surface Condition? (G/P)	Good

Possible Solution	
Possible Solutions:	
Remove & Replace Entire Ramp.	1
•	
	I
	- 1
	- 1
	1
Surveyor Notes:	I
N/A	- 1
	1
PROW/ADA:	
Not Found, R304.5.1, R304.2.2	l

Total Cost:	\$ 1850.00
