Access Compliance Report

Public Rights-of-Way

(Curb Ramps)

Intersection ID: 32230	Main Street: DENNINGTON GROVE LN	Cross Street: HEATHERLY CT	Location: NE
ADA ID: 4D23E5752E41	Ramp Type: BlendTrans1	Initial Pass/Fail: Fail	Overall Compliance: No
Severity Score: 8.75			
Codes/Mitigation Info/Possible Solution		Field Measurements/Component Compliance

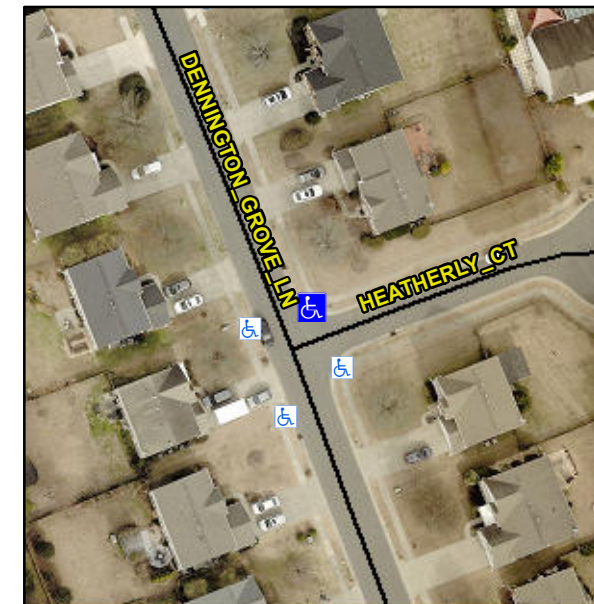
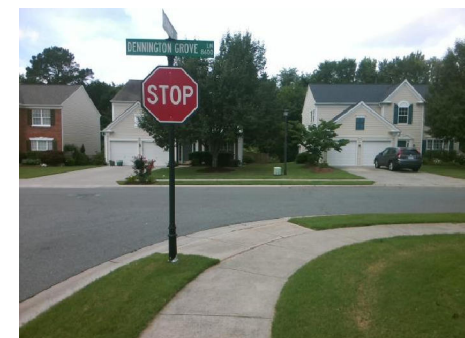
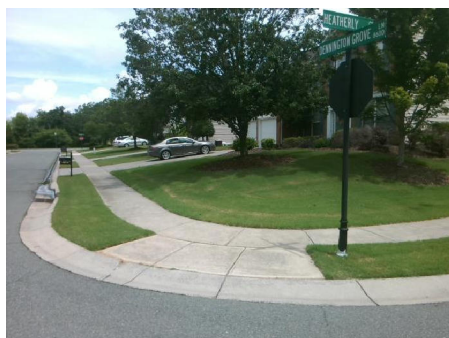
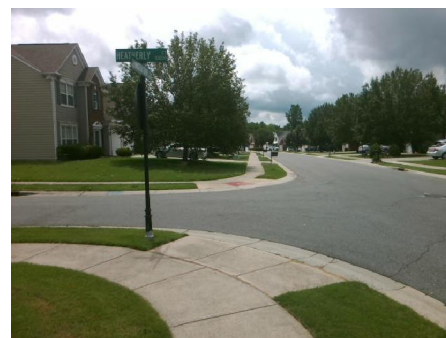
Not Found, R304.5.1

Compliance	Description	Data	Compliance	Description	Data
N/A	Ramp Length (in)	47.0	Yes	BlendTrans Slope (%)	3.0
No	Ramp Width (in)	37.0	Yes	BlendTrans XSlope (%)	1.9
N/A	Flare Type LT	N/A	N/A	Flare Type RT	N/A
N/A	Flare Slope LT (%)	N/A	N/A	Flare Slope RT (%)	N/A
N/A	Flare Traversable LT?	N/A	N/A	Flare Traversable RT?	N/A
N/A	Landing Length (in)	N/A	N/A	DWS Provided?	N/A
N/A	Landing Width (in)	N/A	N/A	DWS Contrast?	N/A
N/A	Landing Slope (%)	N/A	N/A	DWS Length (in)	N/A
N/A	Landing X Slope (%)	N/A	N/A	DWS Full Width?	N/A
N/A	Landing Curb? (Y/N)	N/A	N/A	DWS Offset (in)	N/A
N/A	Shared Landing?	N/A			
N/A	Gutter Ponding?	N/A	N/A	Gutter Slope (%)	N/A
N/A	Gutter Lip Ht (in)	N/A	N/A	Gutter X Slope (%)	N/A
N/A	Painted X Walk1?	No	N/A	Painted X Walk2?	No
	X Walk 1 Direction	To SW		X Walk 2 Direction	To SE
	X Walk 1 Width (in)	N/A		X Walk 2 Width (in)	N/A
	X Walk 1 Slope (%)	2.4		X Walk 2 Slope (%)	1.9
	X Walk 1 X Slope (%)	0.9		X Walk 2 X Slope (%)	0.6

N/A	Ramp inside XWalk1?	N/A	N/A	Ramp inside XWalk2?	N/A
	Road Slope (%)	2.5		Clear Space?	N/A
	Road X Slope (%)	1.3	N/A	Clear Space to XWalk (in)	N/A
N/A	Any Obstructions?	N/A	N/A	Storm Grate/Utility Hazard?	N/A
	Obstruction Type			Storm Grate/Utility Type	
		N/A			N/A
			Yes	Surface Condition? (G/P)	Good
			No	Curb Slope (%)	16.3

Remove & Replace Curb Ramp With Two New Directional Ramps or Equivalent.
