Access Compliance Report

Public Rights-of-Way

(Curb Ramps)

Intersection ID: N/A	Main Street: SOLAR_WY	Cross Street: ROCK_ISLAND_RD	Location: SW
ADA ID: 4D328F137608	Ramp Type: Perp	Initial Pass/Fail: Fail	Overall Compliance: No
Codes/Mitigation Info/Possible Solution		Field Measurements/Component Compliance	
Severity Score: 12.5

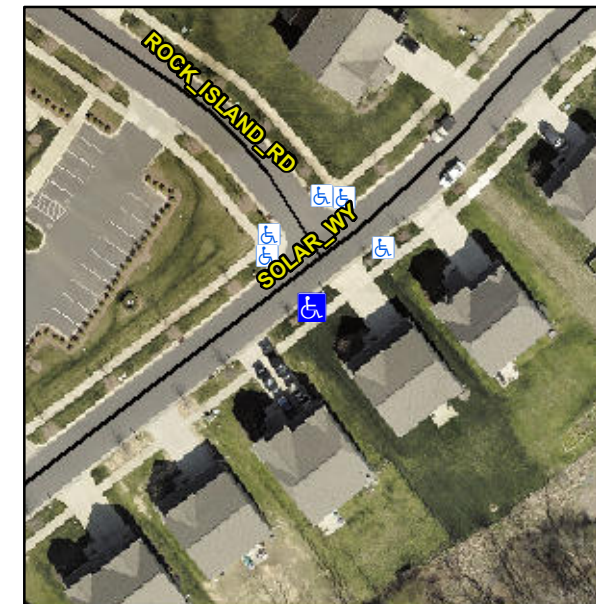
Not Found, R304.5.3

Compliance	Description	Data	Compliance	Description	Data
N/A	Ramp Length (in)	95.0	Yes	Ramp Slope (%)	5.6
Yes	Ramp Width (in)	48.0	No	Ramp XSlope (%)	5.8
N/A	Flare Type LT	N/A	N/A	Flare Type RT	N/A
N/A	Flare Slope LT (%)	N/A	N/A	Flare Slope RT (%)	N/A
N/A	Flare Traversable LT?	N/A	N/A	Flare Traversable RT?	N/A
N/A	Landing Length (in)	N/A	N/A	DWS Provided?	N/A
N/A	Landing Width (in)	N/A	N/A	DWS Contrast?	N/A
N/A	Landing Slope (%)	N/A	N/A	DWS Length (in)	N/A
N/A	Landing X Slope (%)	N/A	N/A	DWS Full Width?	N/A
N/A	Landing Curb? (Y/N)	N/A	N/A	DWS Offset (in)	N/A
N/A	Shared Landing?	N/A			
N/A	Gutter Ponding?	N/A	N/A	Gutter Slope (%)	N/A
N/A	Gutter Lip Ht (in)	N/A	N/A	Gutter X Slope (%)	N/A
N/A	Painted X Walk1?	No	N/A	Painted X Walk2?	N/A
	X Walk 1 Direction	To NW		X Walk 2 Direction	N/A
N/A	X Walk 1 Width (in)	N/A	N/A	X Walk 2 Width (in)	N/A
	X Walk 1 Slope (%)	4.2		X Walk 2 Slope (%)	N/A
	X Walk 1 X Slope (%)	4.8		X Walk 2 X Slope (%)	N/A

N/A	Ramp inside XWalk1?	N/A	N/A	Ramp inside XWalk2?	N/A
	Road Slope (%)	N/A	N/A	Clear Space?	N/A
	Road X Slope (%)	N/A	N/A	Clear Space to XWalk (in)	N/A
N/A	Any Obstructions?	N/A	N/A	Storm Grate/Utility Hazard?	N/A
	Obstruction Type			Storm Grate/Utility Type	
		N/A			N/A
			Yes	Surface Condition? (G/P)	Good

Remove & Replace Entire Ramp.
