## **Access Compliance Report Public Rights-of-Way** (Curb Ramps)

Intersection ID: 25619 Main Street: LITTLE AV **Cross Street: WATERFORD CREST DR** Location: ADA ID: 4D3633BC8F79 Ramp Type: PerpDiag Initial Pass/Fail: Fail **Overall Compliance: No Severity Score:** 25

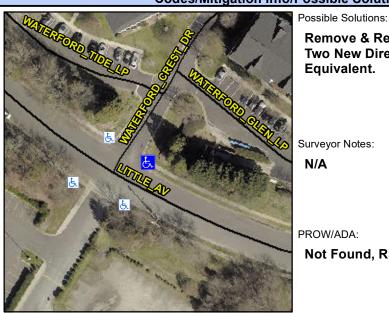
WATERFORD CREST DR Street 1 Name Stop Condition-Street 2 StopSign Street 2 Name LITTLE AV Stop Condition-Street 1 None

Not Found, R304.2.2, R304.5.3

Compl	iance Description	Data	Compl	iance Description	Data
N/A	Ramp Length (in)	69.0	No	Ramp Slope (%)	9.2
Yes	Ramp Width (in)	52.0	No	Ramp XSlope (%)	5.9
N/A	Flare Type LT	N/A	N/A	Flare Type RT	N/A
N/A	Flare Slope LT (%)	N/A	N/A	Flare Slope RT (%)	N/A
N/A	Flare Traversable LT?	N/A	N/A	Flare Traversable RT?	N/A
N/A	Landing Length (in)	N/A	N/A	DWS Provided?	N/A
N/A	Landing Width (in)	N/A	N/A	DWS Contrast?	N/A
N/A	Landing Slope (%)	N/A	N/A	DWS Length (in)	N/A
N/A	Landing X Slope (%)	N/A	N/A	DWS Full Width?	N/A
N/A	Landing Curb? (Y/N)	N/A	N/A	DWS Offset (in)	N/A
N/A	Shared Landing?	N/A			
N/A	Gutter Ponding?	N/A	N/A	Gutter Slope (%)	N/A
N/A	Gutter Lip Ht (in)	N/A	N/A	Gutter X Slope (%)	N/A
N/A	Painted X Walk1?	No	N/A	Painted X Walk2?	No
	X Walk 1 Direction	To NW		X Walk 2 Direction	To SW
N/A	X Walk 1 Width (in)	N/A	N/A	X Walk 2 Width (in)	N/A
	X Walk 1 Slope (%)	3.0		X Walk 2 Slope (%)	3.0
	X Walk 1 X Slope (%)	2.0		X Walk 2 X Slope (%)	2.1

N/A	Ramp inside XWalk1?	N/A	N/A	Ramp inside XWalk2?	N/A
	Road Slope (%)	4.2	N/A	Clear Space?	N/A
	Road X Slope (%)	0.1	N/A	Clear Space to XWalk (in)	N/A
N/A	Any Obstructions?	N/A	N/A	Storm Grate/Utility Hazard?	N/A
	Obstruction Type			Storm Grate/Utility Type	
		N/A			N/A
			Yes	Surface Condition? (G/P)	Good

**Remove & Replace Curb Ramp With Two New Directional Ramps or** Equivalent.
