# Access Compliance Report

## Public Rights-of-Way

### (Curb Ramps)

Intersection ID: 10825	Main Street: E_26TH_ST	Cross Street: N_DAVIDSON_ST	Location:	N
ADA ID: 4D44D657AB1B	Ramp Type: Perp	Initial Pass/Fail: Fail	Overall Compliance: No	Severity Score: 10

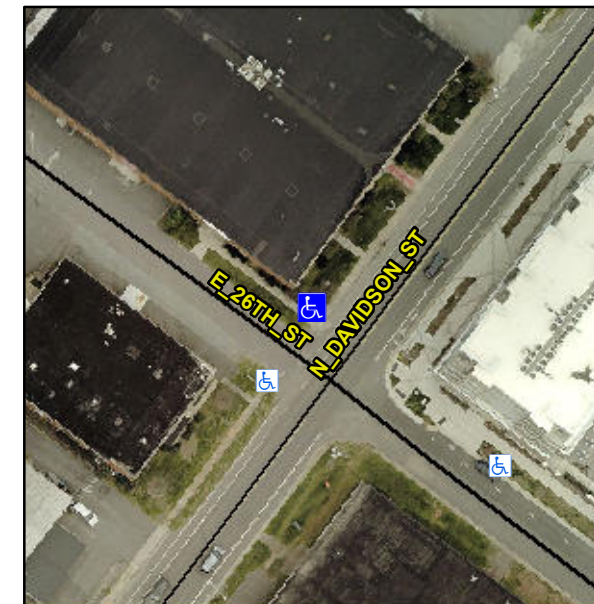
**Not Found, R304.5.1, R304.5.3**

Compliance	Description	Data	Compliance	Description	Data
N/A	Ramp Length (in)	79.0	Yes	Ramp Slope (%)	6.1
No	Ramp Width (in)	42.0	No	Ramp XSlope (%)	4.4
N/A	Flare Type LT	N/A	N/A	Flare Type RT	N/A
N/A	Flare Slope LT (%)	N/A	N/A	Flare Slope RT (%)	N/A
N/A	Flare Traversable LT?	N/A	N/A	Flare Traversable RT?	N/A
N/A	Landing Length (in)	N/A	N/A	DWS Provided?	N/A
N/A	Landing Width (in)	N/A	N/A	DWS Contrast?	N/A
N/A	Landing Slope (%)	N/A	N/A	DWS Length (in)	N/A
N/A	Landing X Slope (%)	N/A	N/A	DWS Full Width?	N/A
N/A	Landing Curb? (Y/N)	N/A	N/A	DWS Offset (in)	N/A
N/A	Shared Landing?	N/A			
N/A	Gutter Ponding?	N/A	N/A	Gutter Slope (%)	N/A
N/A	Gutter Lip Ht (in)	N/A	N/A	Gutter X Slope (%)	N/A
N/A	Painted X Walk1?	No	N/A	Painted X Walk2?	N/A
	X Walk 1 Direction	To SW		X Walk 2 Direction	N/A
N/A	X Walk 1 Width (in)	N/A	N/A	X Walk 2 Width (in)	N/A
	X Walk 1 Slope (%)	3.6		X Walk 2 Slope (%)	N/A
	X Walk 1 X Slope (%)	1.8		X Walk 2 X Slope (%)	N/A

N/A	Ramp inside XWalk1?	N/A	N/A	Ramp inside XWalk2?	N/A
	Road Slope (%)	1.8	N/A	Clear Space?	N/A
	Road X Slope (%)	3.6	N/A	Clear Space to XWalk (in)	N/A
N/A	Any Obstructions?	N/A	N/A	Storm Grate/Utility Hazard?	N/A
	Obstruction Type			Storm Grate/Utility Type	
		N/A			N/A
			Yes	Surface Condition? (G/P)	Good

**Remove & Replace Entire Ramp.**

Total Cost: \$ 1850.00
