# Access Compliance Report

## Public Rights-of-Way

### (Curb Ramps)

| Intersection ID: 52535 | Main Street: TAMARRON_DR | Cross Street: CLAVEMORR_CASTLE_CT | Location: NW |

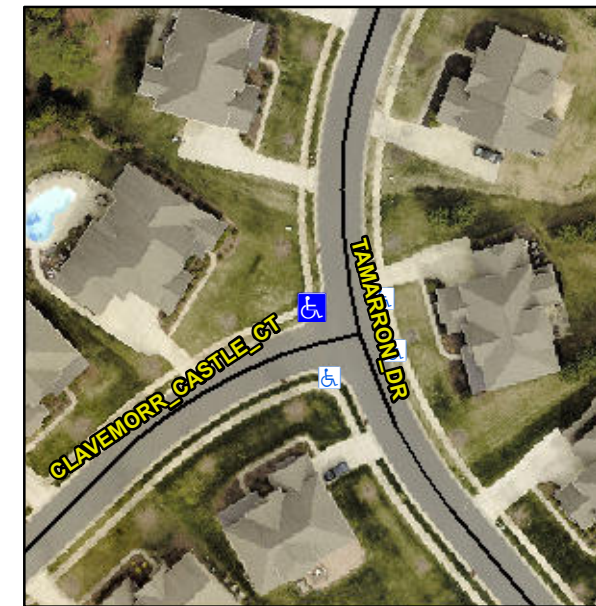
| ADA ID: 4D487BE5249E | Ramp Type: PerpDiag | Initial Pass/Fail: Fail | Overall Compliance: No |
| Severity Score: 10 | | | |

**Not Found, R304.5.1, R304.5.3**

| Compliance | Description | Data | Compliance | Description | Data |
|---|---|---|---|---|---|
| N/A | Ramp Length (in) | 47.0 | Yes | Ramp Slope (%) | 6.0 |
| No | Ramp Width (in) | 47.0 | No | Ramp XSlope (%) | 2.2 |

Possible Solutions:

**Remove & Replace Curb Ramp With Two New Directional Ramps or Equivalent.**

Total Cost: \$ 3200.00
