Access Compliance Report

Public Rights-of-Way (Curb Ramps)

Intersection ID: 2853	Main Street: CARDINAL_POINT_RD	Cross Street: BENFIELD_RD	Location: NW
ADA ID: 4D794DD59B62	Ramp Type: Directional1	Initial Pass/Fail: Pass	Overall Compliance: No
Severity Score: 0			
Codes/Mitigation Info/Possible Solution		Field Measurements/Component Compliance

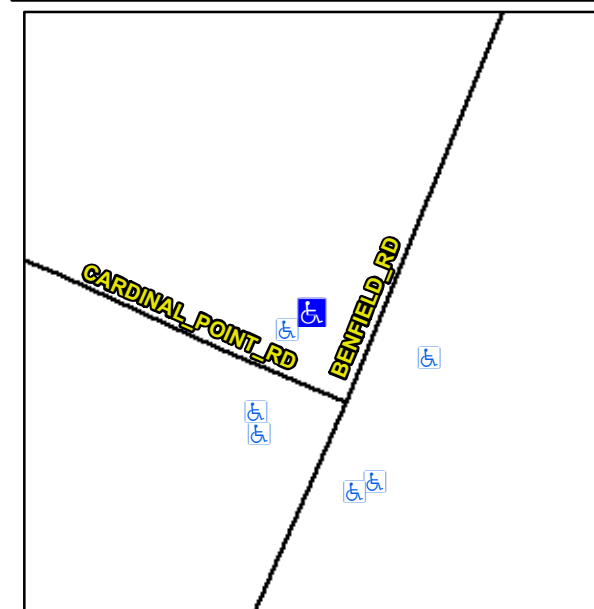
PROW/ADA:

R304.5.3, R304.5.2

Compliance	Description	Data	Compliance	Description	Data
N/A	Ramp Length (in)	74.0	No	Grade Break?	No
Yes	Ramp Width (in)	71.0	N/A	Grade Break Slope (%)	6.5
Yes	Ramp Slope (%)	6.5	N/A	Grade Break XSlope (%)	3.7
Yes	Ramp XSlope (%)	1.7			
Yes	Flare Type LT	N/A	Yes	Flare Type RT	N/A
N/A	Flare Slope LT (%)	N/A	N/A	Flare Slope RT (%)	N/A
N/A	Flare Traversable LT?	No	N/A	Flare Traversable RT?	No
Yes	Landing Length (in)	73.0	Yes	DWS Provided?	Yes
Yes	Landing Width (in)	71.0	Yes	DWS Contrast?	Yes
Yes	Landing Slope (%)	1.1	Yes	DWS Length (in)	24.0
No	Landing X Slope (%)	2.2	Yes	DWS Full Width?	Yes
N/A	Landing Curb? (Y/N)	N/A	Yes	DWS Offset LT (in)	2.0
N/A	Shared Landing?	No	Yes	DWS Offset RT (in)	12.5
Yes	Gutter Ponding?	No	Yes	Gutter Slope (%)	0.1
Yes	Gutter Lip Ht (in)	0.0	Yes	Gutter X Slope (%)	0.6
N/A	Painted X Walk1?	No		Road Slope (%)	4.2
	X Walk 1 Direction	To E		Road X Slope (%)	0.1
	X Walk 1 Width (in)	N/A		Clear Space?	Yes

X Walk 1 Slope (%)	4.2	N/A	Clear Space to XWalk (in)	N/A
	X Walk 1 X Slope (%)	0.1	Yes	Storm Grate/Utility Hazard?	No
N/A	Ramp inside XWalk1?	N/A		Storm Grate/Utility Type	
Yes	Any Obstructions?	No			N/A
	Obstruction Type		Yes	Surface Condition? (G/P)	Good
			N/A	Curb Slope (%)	2.4

Possible Solutions:

Remove & Replace Entire Ramp.
