Access Compliance Report

Public Rights-of-Way

(Curb Ramps)

Intersection ID: 13540	Main Street: LEXINGTON_AV	Cross Street: S_CALDWELL_ST	Location: E
ADA ID: 4D886B4309BC	Ramp Type: BlendTrans1	Initial Pass/Fail: Fail	Overall Compliance: No
Severity Score: 1.25			
Codes/Mitigation Info/Possible Solution		Field Measurements/Component Compliance

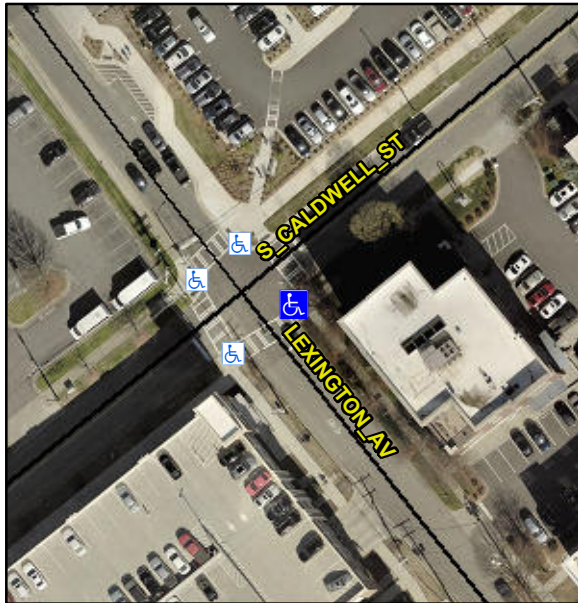
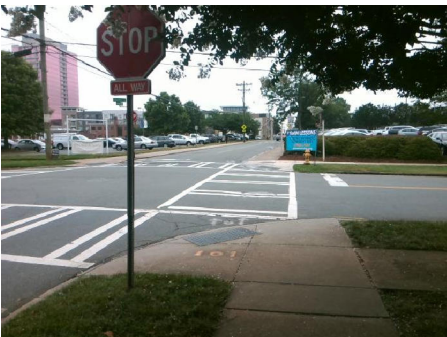
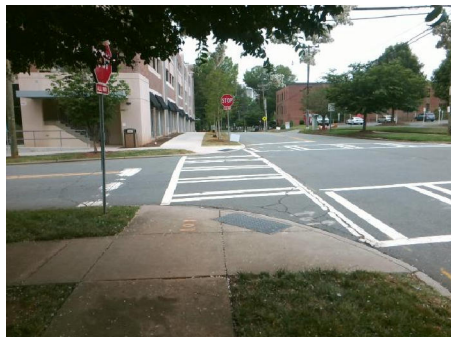
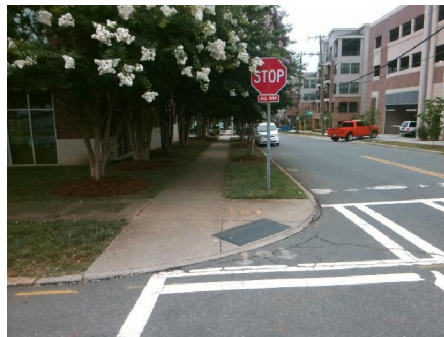
Compliance	Description	Data	Compliance	Description	Data
N/A	Ramp Length (in)	80.0	Yes	BlendTrans Slope (%)	3.5
Yes	Ramp Width (in)	84.0	No	BlendTrans XSlope (%)	2.7
N/A	Flare Type LT	N/A	N/A	Flare Type RT	N/A
N/A	Flare Slope LT (%)	N/A	N/A	Flare Slope RT (%)	N/A
N/A	Flare Traversable LT?	N/A	N/A	Flare Traversable RT?	N/A
N/A	Landing Length (in)	N/A	N/A	DWS Provided?	N/A
N/A	Landing Width (in)	N/A	N/A	DWS Contrast?	N/A
N/A	Landing Slope (%)	N/A	N/A	DWS Length (in)	N/A
N/A	Landing X Slope (%)	N/A	N/A	DWS Full Width?	N/A
N/A	Landing Curb? (Y/N)	N/A	N/A	DWS Offset (in)	N/A
N/A	Shared Landing?	N/A			
N/A	Gutter Ponding?	N/A	N/A	Gutter Slope (%)	N/A
N/A	Gutter Lip Ht (in)	N/A	N/A	Gutter X Slope (%)	N/A
N/A	Painted X Walk1?	Yes	N/A	Painted X Walk2?	Yes
	X Walk 1 Direction	To NW		X Walk 2 Direction	To SW
	X Walk 1 Width (in)	111.0		X Walk 2 Width (in)	112.0
	X Walk 1 Slope (%)	6.2		X Walk 2 Slope (%)	3.9
	X Walk 1 X Slope (%)	1.8		X Walk 2 X Slope (%)	4.6

N/A	Ramp inside XWalk1?	Yes	N/A	Ramp inside XWalk2?	Yes
	Road Slope (%)	2.6		Clear Space?	N/A
	Road X Slope (%)	6.5	N/A	Clear Space to XWalk (in)	N/A
N/A	Any Obstructions?	N/A	N/A	Storm Grate/Utility Hazard?	N/A
	Obstruction Type			Storm Grate/Utility Type	
		N/A			N/A
			Yes	Surface Condition? (G/P)	Good
			N/A	Curb Slope (%)	1.2

Remove & Replace Curb Ramp With Two New Directional Ramps or Equivalent.

R304.5.3
