Access Compliance Report

Public Rights-of-Way

(Curb Ramps)

Intersection ID: 24190	Main Street: CANDLEWYCK_LN	Cross Street: LAWTON BLUFF RD	Location: NW
ADA ID: 4D89F366BD88	Ramp Type: PerpDiag	Initial Pass/Fail: Fail	Overall Compliance: No
Severity Score: 12.5			
Codes/Mitigation Info/Possible Solution		Field Measurements/Component Compliance

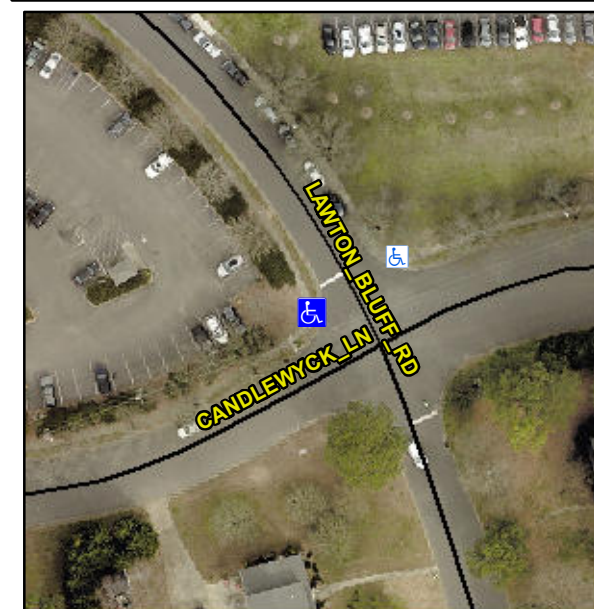
Compliance	Description	Data	Compliance	Description	Data
N/A	Ramp Length (in)	48.0	Yes	Ramp Slope (%)	5.0
Yes	Ramp Width (in)	48.0	No	Ramp XSlope (%)	5.2
N/A	Flare Type LT	N/A	N/A	Flare Type RT	N/A
N/A	Flare Slope LT (%)	N/A	N/A	Flare Slope RT (%)	N/A
N/A	Flare Traversable LT?	N/A	N/A	Flare Traversable RT?	N/A
N/A	Landing Length (in)	N/A	N/A	DWS Provided?	N/A
N/A	Landing Width (in)	N/A	N/A	DWS Contrast?	N/A
N/A	Landing Slope (%)	N/A	N/A	DWS Length (in)	N/A
N/A	Landing X Slope (%)	N/A	N/A	DWS Full Width?	N/A
N/A	Landing Curb? (Y/N)	N/A	N/A	DWS Offset (in)	N/A
N/A	Shared Landing?	N/A			
N/A	Gutter Ponding?	Yes	N/A	Gutter Slope (%)	N/A
N/A	Gutter Lip Ht (in)	N/A	N/A	Gutter X Slope (%)	N/A
N/A	Painted X Walk1?	No	N/A	Painted X Walk2?	No
	X Walk 1 Direction	To S		X Walk 2 Direction	To NE
N/A	X Walk 1 Width (in)	N/A	N/A	X Walk 2 Width (in)	N/A
	X Walk 1 Slope (%)	4.2		X Walk 2 Slope (%)	0.9
	X Walk 1 X Slope (%)	0.8		X Walk 2 X Slope (%)	3.0

N/A	Ramp inside XWalk1?	N/A	N/A	Ramp inside XWalk2?	N/A
	Road Slope (%)	1.0	N/A	Clear Space?	N/A
	Road X Slope (%)	2.2	N/A	Clear Space to XWalk (in)	N/A
N/A	Any Obstructions?	N/A	N/A	Storm Grate/Utility Hazard?	N/A
	Obstruction Type			Storm Grate/Utility Type	
		N/A			N/A
		Yes		Surface Condition? (G/P)	Good

Remove & Replace Curb Ramp With Two New Directional Ramps or Equivalent.
