Access Compliance Report Public Rights-of-Way (Curb Ramps)

Intersection ID: 10006563 Main Street: SHADE_VALLEY_RD Cross Street: OAKHURST_COMMONS_DR Location: SW ADA ID: 4D949ABB9244 Ramp Type: Directional1 Initial Pass/Fail: Fail **Overall Compliance: No** Severity Score: 13.75

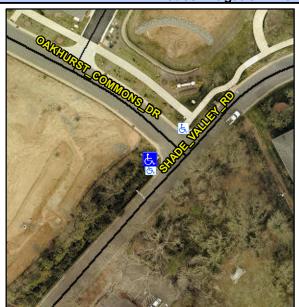
Field Measurements/Component Compliance								
Compl	iance Description	Data	Comp	liance Description	Data			
N/A	Ramp Length (in)	78.0	N/A	Grade Break?	N/A			
Yes	Ramp Width (in)	64.0	N/A	Grade Break Slope (%)	0.0			
No	Ramp Slope (%)	8.7	N/A Grade Break XSlope (%)		0.0			
No	Ramp XSlope (%)	2.7						
N/A	Flare Type LT	N/A	N/A	Flare Type RT	N/A			
N/A	Flare Slope LT (%)	N/A	N/A	Flare Slope RT (%)	0.0			
N/A	Flare Traversable LT?	N/A	N/A	Flare Traversable RT?	N/A			
N/A	Landing Length (in)	0.0	N/A	DWS Provided?	N/A			
N/A	Landing Width (in)	0.0	N/A	DWS Contrast?	N/A			
N/A	Landing Slope (%)	0.0	N/A	DWS Length (in)	N/A			
N/A	Landing X Slope (%)	0.0	N/A	DWS Full Width?	N/A			
N/A	Landing Curb? (Y/N)	N/A	N/A	DWS Offset LT (in)	N/A			
N/A	Shared Landing?	N/A	N/A	DWS Offset RT (in)	N/A			
N/A	Gutter Ponding?	0.0	N/A	Gutter Slope (%)	N/A			
N/A	Gutter Lip Ht (in)	2.0	N/A	Gutter X Slope (%)	N/A			
N/A	Painted X Walk1?	No		Road Slope (%)	2.5

X Walk 1 Direction	To NE		Road X Slope (%)	2.2			
	X Walk 1 Width (in)	N/A		Clear Space?	N/A			
	X Walk 1 Slope (%)	2.5	N/A	Clear Space to XWalk (in)	N/A			
	X Walk 1 X Slope (%)	2.2	N/A	Storm Grate/Utility Hazard?	N/A			
N/A	Ramp inside XWalk1?	N/A		Storm Grate/Utility Type				
N/A	Any Obstructions?	N/A			N/A			
	Obstruction Type		Yes	Surface Condition? (G/P)	Good			
		N/A	N/A	Curb Slope (%)	4.9

Possible Solution		
Possible Solutions:	Compliand	
Remove & Replace Entire Ramp.	N/A	R
•	Yes	R
	No	Ra
	No	Ra
	N/A	FI
	N/A	FI
Surveyor Notes:	N/A	FI
N/A	N/A	La
	N/A	La
	N/A	La
	N/A	La
PROW/ADA:	N/A	La
R304.2.2, R304.5.3	N/A	Sł
·	N/A	G
	N/A	G
	N/A	Pa
		Χ
		Χ
		Χ
		Χ
	N/A	Ra
