Access Compliance Report

Public Rights-of-Way

(Curb Ramps)

Intersection ID: 4470	Main Street: CRAVEN_HILL_DR	Cross Street: LANGSTON_MILL_RD	Location: E
ADA ID: 4D9D91EA6FD3	Ramp Type: Perp	Initial Pass/Fail: Fail	Overall Compliance: No
Severity Score: 21.25			
Codes/Mitigation Info/Possible Solution		Field Measurements/Component Compliance

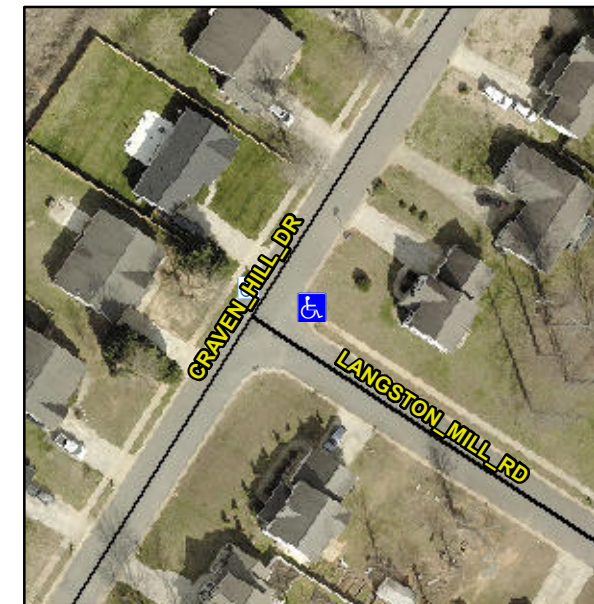
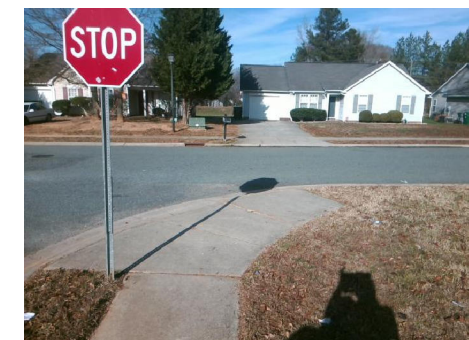
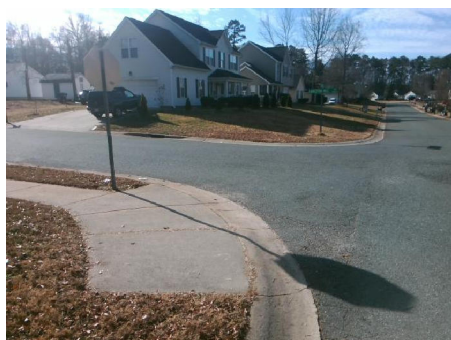
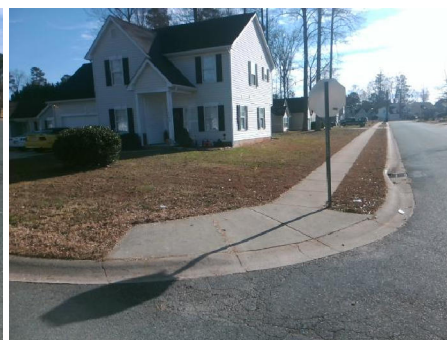
Not Found, R304.5.1, R304.2.2

Compliance	Description	Data	Compliance	Description	Data
N/A	Ramp Length (in)	48.0	No	Ramp Slope (%)	9.4
No	Ramp Width (in)	44.0	Yes	Ramp XSlope (%)	0.5
N/A	Flare Type LT	N/A	N/A	Flare Type RT	N/A
N/A	Flare Slope LT (%)	N/A	N/A	Flare Slope RT (%)	N/A
N/A	Flare Traversable LT?	N/A	N/A	Flare Traversable RT?	N/A
N/A	Landing Length (in)	N/A	N/A	DWS Provided?	N/A
N/A	Landing Width (in)	N/A	N/A	DWS Contrast?	N/A
N/A	Landing Slope (%)	N/A	N/A	DWS Length (in)	N/A
N/A	Landing X Slope (%)	N/A	N/A	DWS Full Width?	N/A
N/A	Landing Curb? (Y/N)	N/A	N/A	DWS Offset (in)	N/A
N/A	Shared Landing?	N/A			
N/A	Gutter Ponding?	N/A	N/A	Gutter Slope (%)	N/A
N/A	Gutter Lip Ht (in)	N/A	N/A	Gutter X Slope (%)	N/A
N/A	Painted X Walk1?	No	N/A	Painted X Walk2?	N/A
	X Walk 1 Direction	To NW		X Walk 2 Direction	N/A
N/A	X Walk 1 Width (in)	N/A	N/A	X Walk 2 Width (in)	N/A
	X Walk 1 Slope (%)	0.9		X Walk 2 Slope (%)	N/A
	X Walk 1 X Slope (%)	2.3		X Walk 2 X Slope (%)	N/A

N/A	Ramp inside XWalk1?	N/A	N/A	Ramp inside XWalk2?	N/A
	Road Slope (%)	N/A	N/A	Clear Space?	N/A
	Road X Slope (%)	N/A	N/A	Clear Space to XWalk (in)	N/A
N/A	Any Obstructions?	N/A	N/A	Storm Grate/Utility Hazard?	N/A
	Obstruction Type			Storm Grate/Utility Type	
		N/A			N/A
			Yes	Surface Condition? (G/P)	Good

Possible Solutions:

Remove & Replace Entire Ramp.
