## **Access Compliance Report Public Rights-of-Way** (Curb Ramps)

Intersection ID: 48986 Main Street: SARDIS RD **Cross Street: KINGSDOWN AV** Location: NW **Overall Compliance: No Severity Score:** ADA ID: 4DC0026D3ABD Ramp Type: PerpDiag Initial Pass/Fail: Fail 12.5

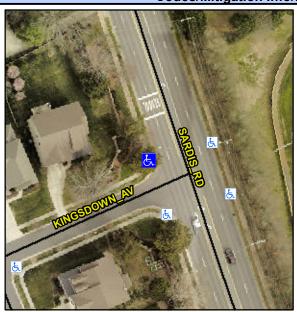
KINGSDOWN AV Street 1 Name Stop Condition-Street 2 StopSign **SARDIS RD** Street 2 Name Stop Condition-Street 1

Possible Solutions: Remove & Replace Curb Ramp With Two New Directional Ramps or Equivalent. Surveyor Notes: N/A PROW/ADA: R304.2.2
