Access Compliance Report

Public Rights-of-Way

(Curb Ramps)

Intersection ID: N/A	Main Street: PROVIDENCE_RD	Cross Street: SOUTHGROVE_ST	Location: NE
ADA ID: 4DC815150ADD	Ramp Type: PerpDiag	Initial Pass/Fail: Fail	Overall Compliance: No
		Severity Score: 8.75	
Codes/Mitigation Info/Possible Solution		Field Measurements/Component Compliance

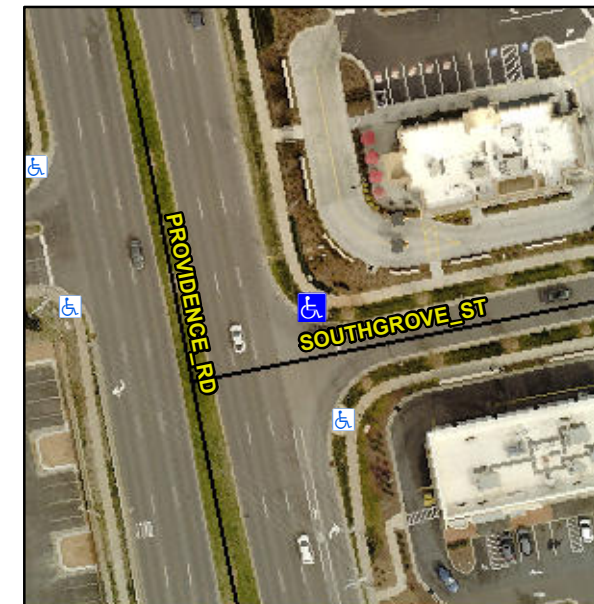
PROW/ADA:

Not Found, R304.5.1

Compliance	Description	Data	Compliance	Description	Data
N/A	Ramp Length (in)	95.0	Yes	Ramp Slope (%)	5.4
No	Ramp Width (in)	47.0	Yes	Ramp XSlope (%)	1.4
N/A	Flare Type LT	N/A	N/A	Flare Type RT	N/A
N/A	Flare Slope LT (%)	N/A	N/A	Flare Slope RT (%)	N/A
N/A	Flare Traversable LT?	N/A	N/A	Flare Traversable RT?	N/A
N/A	Landing Length (in)	N/A	N/A	DWS Provided?	N/A
N/A	Landing Width (in)	N/A	N/A	DWS Contrast?	N/A
N/A	Landing Slope (%)	N/A	N/A	DWS Length (in)	N/A
N/A	Landing X Slope (%)	N/A	N/A	DWS Full Width?	N/A
N/A	Landing Curb? (Y/N)	N/A	N/A	DWS Offset (in)	N/A
N/A	Shared Landing?	N/A			
N/A	Gutter Ponding?	N/A	N/A	Gutter Slope (%)	N/A
N/A	Gutter Lip Ht (in)	N/A	N/A	Gutter X Slope (%)	N/A
N/A	Painted X Walk1?	No	N/A	Painted X Walk2?	No
	X Walk 1 Direction	To W		X Walk 2 Direction	To S
N/A	X Walk 1 Width (in)	N/A	N/A	X Walk 2 Width (in)	N/A
	X Walk 1 Slope (%)	0.5		X Walk 2 Slope (%)	2.3
	X Walk 1 X Slope (%)	2.2		X Walk 2 X Slope (%)	1.1

N/A	Ramp inside XWalk1?	N/A	N/A	Ramp inside XWalk2?	N/A
	Road Slope (%)	1.1	N/A	Clear Space?	N/A
	Road X Slope (%)	1.6	N/A	Clear Space to XWalk (in)	N/A
N/A	Any Obstructions?	N/A	N/A	Storm Grate/Utility Hazard?	N/A
	Obstruction Type			Storm Grate/Utility Type	
		N/A			N/A
		Yes		Surface Condition? (G/P)	Good

Possible Solutions:

Remove & Replace Curb Ramp With Two New Directional Ramps or Equivalent.
