# Access Compliance Report

## Public Rights-of-Way

### (Curb Ramps)

Intersection ID: 8857	Main Street: DORTON_ST	Cross Street: N_TRYON_ST	Location: NW
ADA ID: 4DCD5739FB36	Ramp Type: Perp	Initial Pass/Fail: Fail	Overall Compliance: No
Severity Score: 22.5			
Codes/Mitigation Info/Possible Solution		Field Measurements/Component Compliance

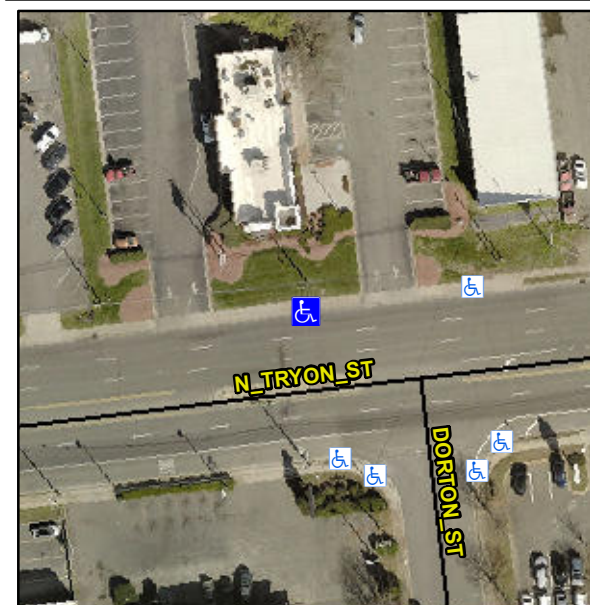
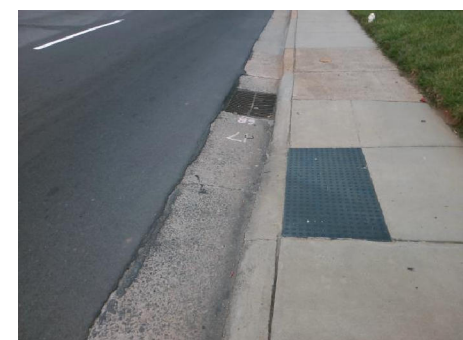
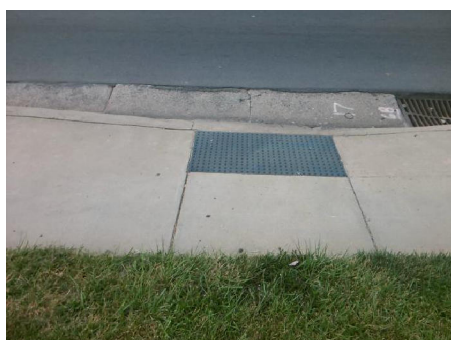
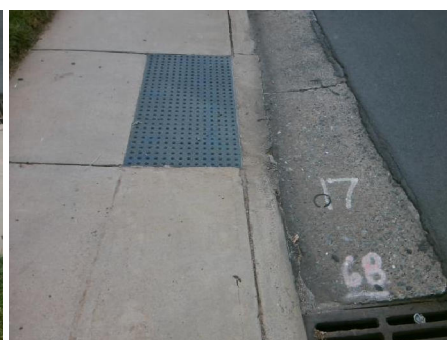
**Not Found, R304.5.1, R304.2.2, R304.5.3**

Compliance	Description	Data	Compliance	Description	Data
N/A	Ramp Length (in)	57.5	No	Ramp Slope (%)	8.9
No	Ramp Width (in)	47.0	No	Ramp XSlope (%)	4.0
N/A	Flare Type LT	N/A	N/A	Flare Type RT	N/A
N/A	Flare Slope LT (%)	N/A	N/A	Flare Slope RT (%)	N/A
N/A	Flare Traversable LT?	N/A	N/A	Flare Traversable RT?	N/A
N/A	Landing Length (in)	N/A	N/A	DWS Provided?	N/A
N/A	Landing Width (in)	N/A	N/A	DWS Contrast?	N/A
N/A	Landing Slope (%)	N/A	N/A	DWS Length (in)	N/A
N/A	Landing X Slope (%)	N/A	N/A	DWS Full Width?	N/A
N/A	Landing Curb? (Y/N)	N/A	N/A	DWS Offset (in)	N/A
N/A	Shared Landing?	N/A			
N/A	Gutter Ponding?	N/A	N/A	Gutter Slope (%)	N/A
N/A	Gutter Lip Ht (in)	N/A	N/A	Gutter X Slope (%)	N/A
N/A	Painted X Walk1?	No	N/A	Painted X Walk2?	N/A
	X Walk 1 Direction	To S		X Walk 2 Direction	N/A
N/A	X Walk 1 Width (in)	N/A	N/A	X Walk 2 Width (in)	N/A
	X Walk 1 Slope (%)	2.7		X Walk 2 Slope (%)	N/A
	X Walk 1 X Slope (%)	2.4		X Walk 2 X Slope (%)	N/A

N/A	Ramp inside XWalk1?	N/A	N/A	Ramp inside XWalk2?	N/A
	Road Slope (%)	N/A	N/A	Clear Space?	N/A
	Road X Slope (%)	N/A	N/A	Clear Space to XWalk (in)	N/A
N/A	Any Obstructions?	N/A	N/A	Storm Grate/Utility Hazard?	N/A
	Obstruction Type			Storm Grate/Utility Type	
		N/A			N/A
			Yes	Surface Condition? (G/P)	Good

Possible Solutions:

**Remove & Replace Entire Ramp.**
