Access Compliance Report Public Rights-of-Way (Curb Ramps)

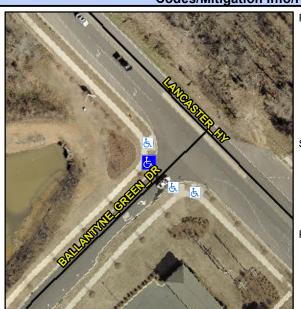
Total Cost: 1850.00

Field Measurements/Component Compliance						
Compl	iance Description	Data	Comp	liance	Description	Data
N/A	Ramp Length (in)	96.0	No	Ram	Slope (%)	9.4
No	Ramp Width (in)	42.0	No	Ramp	XSlope (%)	3.1
N/A	Flare Type LT	N/A	N/A	Flare Type RT		N/A
N/A	Flare Slope LT (%)	N/A	N/A	Flare	Slope RT (%)	N/A
N/A	Flare Traversable LT?	N/A	N/A	Flare	Traversable RT?	N/A
N/A	Landing Length (in)	N/A	N/A	DWS	Provided?	N/A
N/A	Landing Width (in)	N/A	N/A	DWS	Contrast?	N/A
N/A	Landing Slope (%)	N/A	N/A	DWS	Length (in)	N/A
N/A	Landing X Slope (%)	N/A	N/A	DWS	Full Width?	N/A
N/A	Landing Curb? (Y/N)	N/A	N/A	DWS	Offset (in)	N/A
N/A	Shared Landing?	N/A				
N/A	Gutter Ponding?	N/A	N/A	Gutte	er Slope (%)	N/A
N/A	Gutter Lip Ht (in)	N/A	N/A	Gutte	er X Slope (%)	N/A
N/A	Painted X Walk1?	No	N/A	Paint	ed X Walk2?	N/A
	X Walk 1 Direction	To SE		X Wa	lk 2 Direction	N/A
N/A	X Walk 1 Width (in)	N/A	N/A	X Wa	lk 2 Width (in)	N/A
	X Walk 1 Slope (%)	3.9		X Wa	lk 2 Slope (%)	N/A
