## **Access Compliance Report Public Rights-of-Way** (Curb Ramps)

Intersection ID: 7979 Main Street: EAGLE PEAK DR **Cross Street: DAVID AV** Location: N/A **Overall Compliance: No Severity Score:** ADA ID: 4E25658972F6 Ramp Type: Perp Initial Pass/Fail: Fail 10

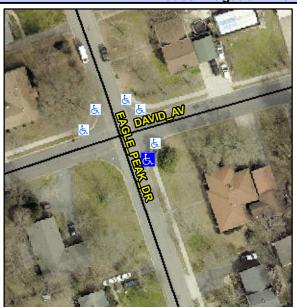
Field Measurements/Component Compliance					
Compliance Description D		Data	Comp	liance Description	Data
N/A	Ramp Length (in)	48.0	Yes	Ramp Slope (%)	6.0
No	Ramp Width (in)	47.0	Yes	Ramp XSlope (%)	4.1
N/A	Flare Type LT	N/A	N/A	Flare Type RT	N/A
N/A	Flare Slope LT (%)	N/A	N/A	Flare Slope RT (%)	N/A
N/A	Flare Traversable LT?	N/A	N/A	Flare Traversable RT?	N/A
N/A	Landing Length (in)	N/A	N/A	DWS Provided?	N/A
N/A	Landing Width (in)	N/A	N/A	DWS Contrast?	N/A
N/A	Landing Slope (%)	N/A	N/A	DWS Length (in)	N/A
N/A	Landing X Slope (%)	N/A	N/A	DWS Full Width?	N/A
N/A	Landing Curb? (Y/N)	N/A	N/A	DWS Offset (in)	N/A
N/A	Shared Landing?	N/A			
N/A	Gutter Ponding?	N/A	N/A	Gutter Slope (%)	N/A
N/A	Gutter Lip Ht (in)	1.0	N/A	Gutter X Slope (%)	N/A
N/A	Painted X Walk1?	No	N/A	Painted X Walk2?	N/A
	X Walk 1 Direction	To W		X Walk 2 Direction	N/A
N/A	X Walk 1 Width (in)	N/A	N/A	X Walk 2 Width (in)	N/A
	X Walk 1 Slope (%)	7.1		X Walk 2 Slope (%)	N/A

X Walk 1 X Slope (%)	4.1		X Walk 2 X Slope (%)	N/A
N/A	Ramp inside XWalk1?	N/A	N/A	Ramp inside XWalk2?	N/A
	Road Slope (%)	4.1	N/A	Clear Space?	N/A
	Road X Slope (%)	7.1	N/A	Clear Space to XWalk (in)	N/A
N/A	Any Obstructions?	N/A	N/A	Storm Grate/Utility Hazard?	N/A
	Obstruction Type			Storm Grate/Utility Type	
		N/A			N/A
			Yes	Surface Condition? (G/P)	Good

**EAGLE PEAK DR** Street 1 Name Stop Condition-Street 2 None Street 2 Name N/A Stop Condition-Street 1 N/A Possible Solutions: Remove & Replace Entire Ramp. Surveyor Notes: N/A PROW/ADA: Not Found, R304.5.1
