Access Compliance Report

Public Rights-of-Way

(Curb Ramps)

Intersection ID: 7289	Main Street: GLORYLAND_AV	Cross Street: N_TRYON_ST	Location: SE
ADA ID: 4E3562D58E92	Ramp Type: Directional1	Initial Pass/Fail: Fail	Overall Compliance: No
		Severity Score: 12.5

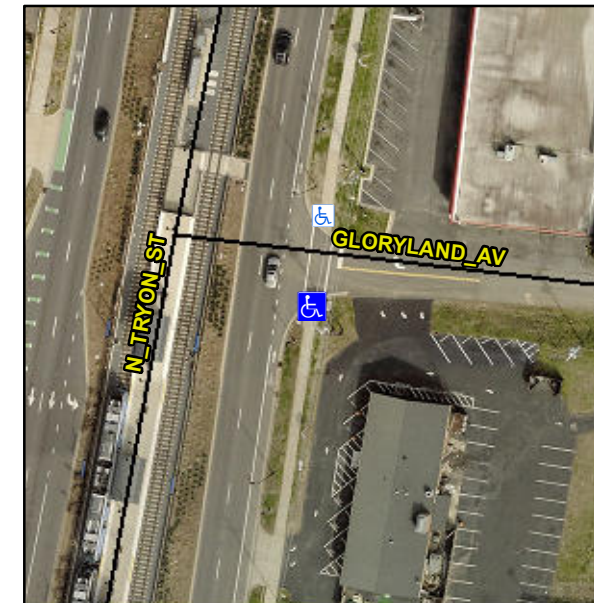
Compliance	Description	Data	Compliance	Description	Data
N/A	Ramp Length (in)	103.0	N/A	Grade Break?	N/A
Yes	Ramp Width (in)	72.0	N/A	Grade Break Slope (%)	0.0
No	Ramp Slope (%)	8.6	N/A	Grade Break XSlope (%)	0.0
Yes	Ramp XSlope (%)	1.5			
N/A	Flare Type LT	N/A	N/A	Flare Type RT	N/A
N/A	Flare Slope LT (%)	N/A	N/A	Flare Slope RT (%)	0.0
N/A	Flare Traversable LT?	N/A	N/A	Flare Traversable RT?	N/A
N/A	Landing Length (in)	0.0	N/A	DWS Provided?	N/A
N/A	Landing Width (in)	0.0	N/A	DWS Contrast?	N/A
N/A	Landing Slope (%)	0.0	N/A	DWS Length (in)	N/A
N/A	Landing X Slope (%)	0.0	N/A	DWS Full Width?	N/A
N/A	Landing Curb? (Y/N)	N/A	N/A	DWS Offset LT (in)	N/A
N/A	Shared Landing?	N/A	N/A	DWS Offset RT (in)	N/A
N/A	Gutter Ponding?	0.0	N/A	Gutter Slope (%)	N/A
N/A	Gutter Lip Ht (in)	0.0	N/A	Gutter X Slope (%)	N/A
N/A	Painted X Walk1?	Yes		Road Slope (%)	1.0
	X Walk 1 Direction	To N		Road X Slope (%)	2.4
	X Walk 1 Width (in)	116.0		Clear Space?	N/A

X Walk 1 Slope (%)	1.0	N/A	Clear Space to XWalk (in)	N/A
	X Walk 1 X Slope (%)	2.4	N/A	Storm Grate/Utility Hazard?	N/A
N/A	Ramp inside XWalk1?	Yes		Storm Grate/Utility Type	
N/A	Any Obstructions?	N/A			N/A
	Obstruction Type		Yes	Surface Condition? (G/P)	Good
			N/A	Curb Slope (%)	2.1

Possible Solutions:

Remove & Replace Entire Ramp.
