# Access Compliance Report

## Public Rights-of-Way

### (Curb Ramps)

Intersection ID: 30315	Main Street: CANNONBALL_DR	Cross Street: EUROSTAR_DR	Location: E
ADA ID: 4E5703788B30	Ramp Type: PerpDiag	Initial Pass/Fail: Pass	Overall Compliance: No
		Severity Score: 15.25

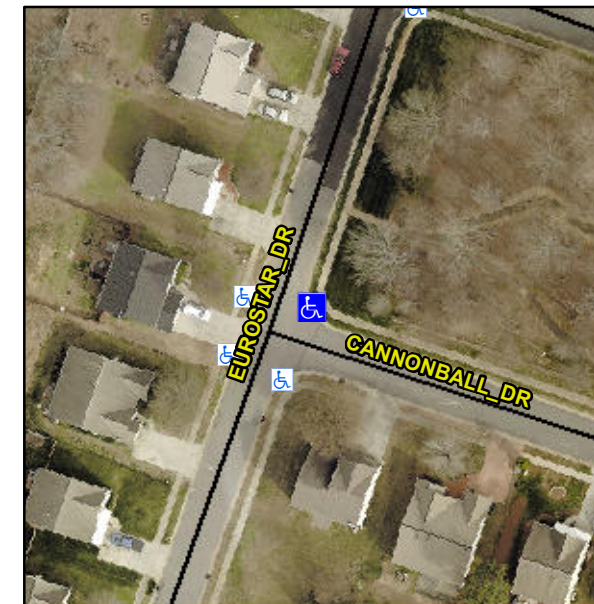
**Not Found, R304.5.3, R304.2.2-Perp, R304.3.2-Para, R305, R304.5.4**

Compliance	Description	Data	Compliance	Description	Data
N/A	Ramp Length (in)	46.0	Yes	Ramp Slope (%)	7.7
Yes	Ramp Width (in)	48.0	No	Ramp XSlope (%)	4.2
N/A	Flare Type LT	Sloped	N/A	Flare Type RT	N/A
N/A	Flare Slope LT (%)	0.1	N/A	Flare Slope RT (%)	8.7
N/A	Flare Traversable LT?	No	N/A	Flare Traversable RT?	No
Yes	Landing Length (in)	48.5	No	DWS Provided?	No
Yes	Landing Width (in)	48.0	N/A	DWS Contrast?	No
No	Landing Slope (%)	2.2	N/A	DWS Length (in)	N/A
No	Landing X Slope (%)	4.9	N/A	DWS Full Width?	No
N/A	Landing Curb? (Y/N)	No	N/A	DWS Offset (in)	N/A
N/A	Shared Landing?	No			
Yes	Gutter Ponding?	No	No	Gutter Slope (%)	10.7
Yes	Gutter Lip Ht (in)	0.0	No	Gutter X Slope (%)	4.8
N/A	Painted X Walk1?	No	N/A	Painted X Walk2?	No
	X Walk 1 Direction	To NW		X Walk 2 Direction	To SW
N/A	X Walk 1 Width (in)	N/A	N/A	X Walk 2 Width (in)	N/A
	X Walk 1 Slope (%)	6.5		X Walk 2 Slope (%)	0.4
	X Walk 1 X Slope (%)	0.2		X Walk 2 X Slope (%)	4.2

N/A	Ramp inside XWalk1?	N/A	N/A	Ramp inside XWalk2?	N/A
	Road Slope (%)	3.7	N/A	Clear Space?	Yes
	Road X Slope (%)	3.5	N/A	Clear Space to XWalk (in)	N/A
Yes	Any Obstructions?	No	Yes	Storm Grate/Utility Hazard?	No
	Obstruction Type			Storm Grate/Utility Type	
		N/A			N/A
			Yes	Surface Condition? (G/P)	Good

**Remove & Replace Curb Ramp With Two New Directional Ramps or Equivalent. Remove & Replace Gutter.**

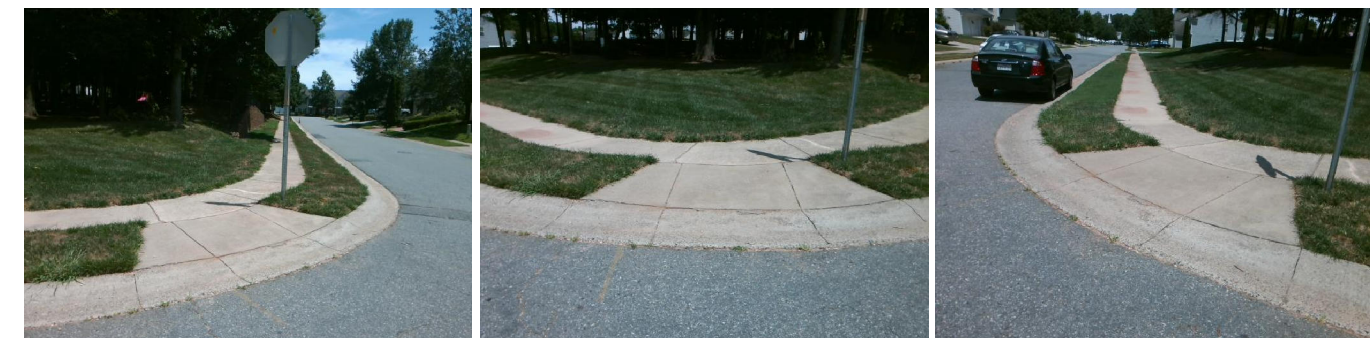
Street 1 Name EUROSTAR DR  
 Stop Condition-Street 2 None  
 Street 2 Name CANNONBALL DR  
 Stop Condition-Street 1 StopSign
