Access Compliance Report

Public Rights-of-Way

(Curb Ramps)

Intersection ID: 45281	Main Street: CIERA_NICHOLE_CT	Cross Street: LAKEHILL_RD	Location: S
ADA ID: 4E581440C850	Ramp Type: PerpDiag	Initial Pass/Fail: Fail	Overall Compliance: No
Codes/Mitigation Info/Possible Solution		Field Measurements/Component Compliance	
Severity Score: 37.5

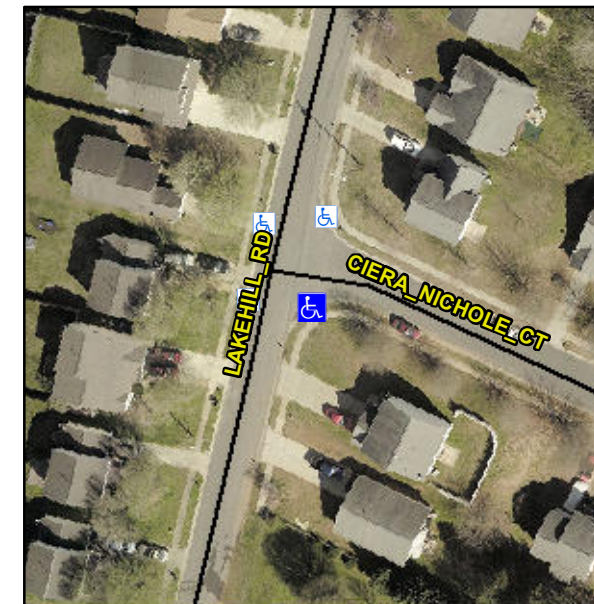
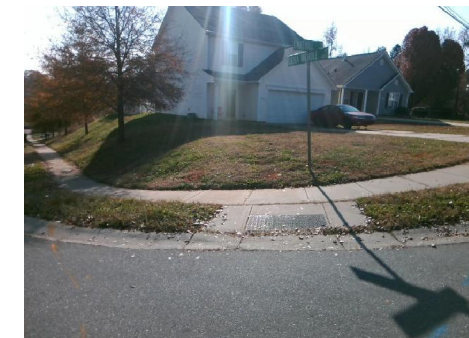
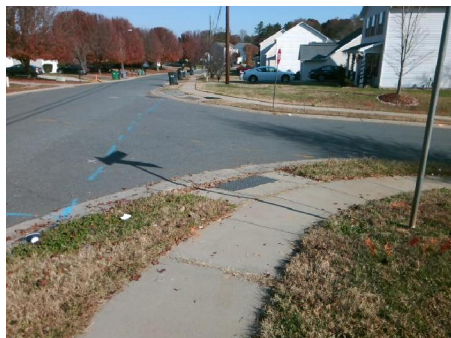
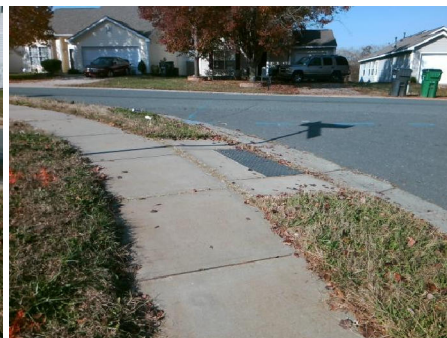
Compliance	Description	Data	Compliance	Description	Data
N/A	Ramp Length (in)	48.5	No	Ramp Slope (%)	8.9
Yes	Ramp Width (in)	48.5	No	Ramp XSlope (%)	9.2
N/A	Flare Type LT	N/A	N/A	Flare Type RT	N/A
N/A	Flare Slope LT (%)	N/A	N/A	Flare Slope RT (%)	N/A
N/A	Flare Traversable LT?	N/A	N/A	Flare Traversable RT?	N/A
N/A	Landing Length (in)	N/A	N/A	DWS Provided?	N/A
N/A	Landing Width (in)	N/A	N/A	DWS Contrast?	N/A
N/A	Landing Slope (%)	N/A	N/A	DWS Length (in)	N/A
N/A	Landing X Slope (%)	N/A	N/A	DWS Full Width?	N/A
N/A	Landing Curb? (Y/N)	N/A	N/A	DWS Offset (in)	N/A
N/A	Shared Landing?	N/A			
N/A	Gutter Ponding?	N/A	N/A	Gutter Slope (%)	N/A
N/A	Gutter Lip Ht (in)	N/A	N/A	Gutter X Slope (%)	N/A
N/A	Painted X Walk1?	No	N/A	Painted X Walk2?	No
	X Walk 1 Direction	To NE		X Walk 2 Direction	To NW
N/A	X Walk 1 Width (in)	N/A	N/A	X Walk 2 Width (in)	N/A
	X Walk 1 Slope (%)	2.1		X Walk 2 Slope (%)	11.5
	X Walk 1 X Slope (%)	11.1		X Walk 2 X Slope (%)	0.7

N/A	Ramp inside XWalk1?	N/A	N/A	Ramp inside XWalk2?	N/A
	Road Slope (%)	8.2	N/A	Clear Space?	N/A
	Road X Slope (%)	8.5	N/A	Clear Space to XWalk (in)	N/A
N/A	Any Obstructions?	N/A	N/A	Storm Grate/Utility Hazard?	N/A
	Obstruction Type			Storm Grate/Utility Type	
		N/A			N/A
			Yes	Surface Condition? (G/P)	Good

Possible Solutions:

Remove & Replace Curb Ramp With Two New Directional Ramps or Equivalent.

R304.2.2, R304.5.3
