Access Compliance Report

Public Rights-of-Way

(Curb Ramps)

Intersection ID: 27197	Main Street: BALLANTYNE_COMMONS_PY	Cross Street: CRESTWOOD_DR	Location: SW
ADA ID: 4E660514C2EA	Ramp Type: Perp	Initial Pass/Fail: Fail	Overall Compliance: No
Severity Score: 22.5			
Codes/Mitigation Info/Possible Solution		Field Measurements/Component Compliance

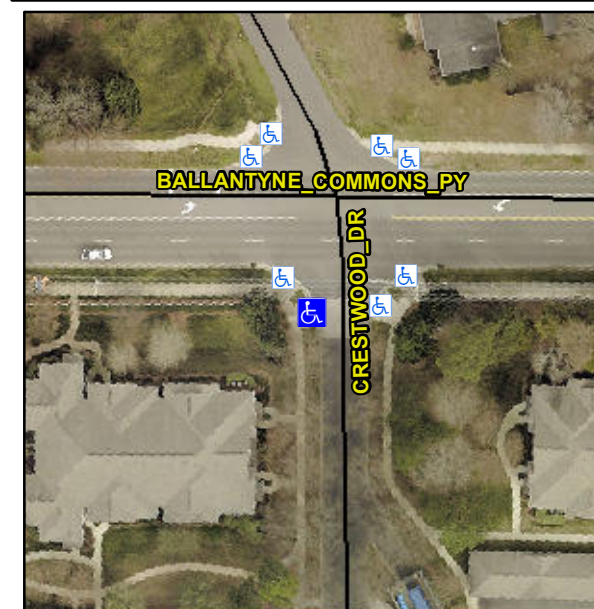
Compliance	Description	Data	Compliance	Description	Data
N/A	Ramp Length (in)	98.0	No	Ramp Slope (%)	8.8
No	Ramp Width (in)	37.0	No	Ramp XSlope (%)	4.2
N/A	Flare Type LT	N/A	N/A	Flare Type RT	N/A
N/A	Flare Slope LT (%)	N/A	N/A	Flare Slope RT (%)	N/A
N/A	Flare Traversable LT?	N/A	N/A	Flare Traversable RT?	N/A
N/A	Landing Length (in)	N/A	N/A	DWS Provided?	N/A
N/A	Landing Width (in)	N/A	N/A	DWS Contrast?	N/A
N/A	Landing Slope (%)	N/A	N/A	DWS Length (in)	N/A
N/A	Landing X Slope (%)	N/A	N/A	DWS Full Width?	N/A
N/A	Landing Curb? (Y/N)	N/A	N/A	DWS Offset (in)	N/A
N/A	Shared Landing?	N/A			
N/A	Gutter Ponding?	N/A	N/A	Gutter Slope (%)	N/A
N/A	Gutter Lip Ht (in)	N/A	N/A	Gutter X Slope (%)	N/A
N/A	Painted X Walk1?	No	N/A	Painted X Walk2?	N/A
	X Walk 1 Direction	To E		X Walk 2 Direction	N/A
N/A	X Walk 1 Width (in)	N/A	N/A	X Walk 2 Width (in)	N/A
	X Walk 1 Slope (%)	0.2		X Walk 2 Slope (%)	N/A
	X Walk 1 X Slope (%)	3.3		X Walk 2 X Slope (%)	N/A

N/A	Ramp inside XWalk1?	N/A	N/A	Ramp inside XWalk2?	N/A
	Road Slope (%)	N/A	N/A	Clear Space?	N/A
	Road X Slope (%)	N/A	N/A	Clear Space to XWalk (in)	N/A
N/A	Any Obstructions?	N/A	N/A	Storm Grate/Utility Hazard?	N/A
	Obstruction Type			Storm Grate/Utility Type	
		N/A			N/A
			Yes	Surface Condition? (G/P)	Good

Possible Solutions:

Remove & Replace Entire Ramp.

R304.5.1, R304.2.2, R304.5.3
