# Access Compliance Report

## Public Rights-of-Way

### (Curb Ramps)

Intersection ID: 9575	Main Street: CATALINA_AV	Cross Street: WINSTON_ST	Location: W
ADA ID: 4E6B56D781C9	Ramp Type: Combination2	Initial Pass/Fail: Fail	Overall Compliance: No
			Severity Score: 13.75

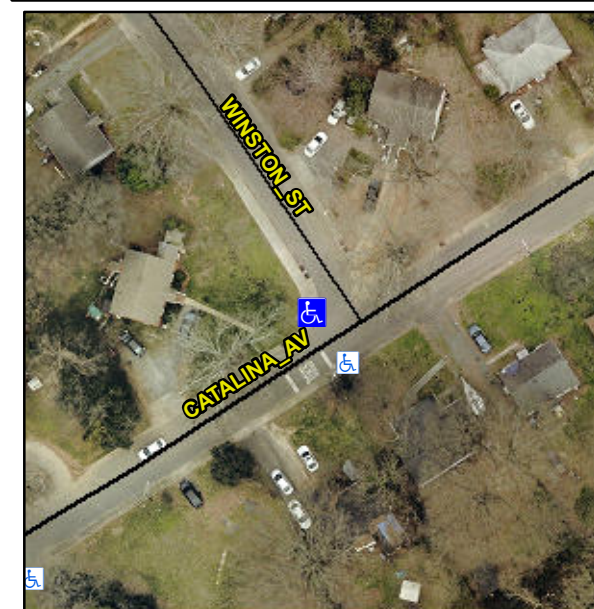
**RT RP < 5%**

**Not Found, R304.3.2, R304.5.3**

Compliance	Description	Data	Compliance	Description	Data
N/A	Ramp Length LT (in)	47.0	N/A	Ramp Length RT (in)	38.5
Yes	Ramp Width LT (in)	49.0	N/A	Ramp Width RT (in)	49.0
No	Ramp Slope LT (%)	8.4	N/A	Ramp Slope RT (%)	4.3
No	Ramp XSlope LT (%)	4.8	N/A	Ramp XSlope RT (%)	2.2
N/A	Ramp Length (in)	24.0	Yes	Ramp Slope (%)	5.2
Yes	Ramp Width (in)	48.0	Yes	Ramp XSlope (%)	1.8
N/A	Flare Type LT	N/A	N/A	Flare Type RT	N/A
N/A	Flare Slope LT (%)	N/A	N/A	Flare Slope RT (%)	N/A
N/A	Flare Traversable LT?	N/A	N/A	Flare Traversable RT?	N/A
N/A	Landing Length (in)	N/A	N/A	DWS Provided?	N/A
N/A	Landing Width (in)	N/A	N/A	DWS Contrast?	N/A
N/A	Landing Slope (%)	N/A	N/A	DWS Length (in)	N/A
N/A	Landing X Slope (%)	N/A	N/A	DWS Full Width?	N/A
N/A	Landing Curb? (Y/N)	N/A	N/A	DWS Offset (in)	N/A
N/A	Shared Landing?	N/A			
N/A	Gutter Ponding?	N/A	N/A	Gutter Slope (%)	N/A
N/A	Gutter Lip Ht (in)	N/A	N/A	Gutter X Slope (%)	N/A
N/A	Painted X Walk1?	No	N/A	Painted X Walk2?	N/A

X Walk 1 Direction	To SE		X Walk 2 Direction	N/A
	X Walk 1 Width (in)	N/A		X Walk 2 Width (in)	N/A
	X Walk 1 Slope (%)	3.2		X Walk 2 Slope (%)	N/A
	X Walk 1 X Slope (%)	3.3		X Walk 2 X Slope (%)	N/A
N/A	Ramp inside XWalk1?	N/A	N/A	Ramp inside XWalk2?	N/A
	Road Slope (%)	N/A		Clear Space?	N/A
	Road X Slope (%)	N/A	N/A	Clear Space to XWalk (in)	N/A
			N/A	Any Obstruction?	N/A
				Obstruction Type	N/A
			N/A	Storm Grate/Utility Hazard?	N/A
				Storm Grate/Utility Type	N/A
Yes	Surface Condition? (G/P)	Good			
	Curb Slope (%)	9.4

**Remove & Replace Entire Ramp.**

Total Cost: \$ 1600.00
