Intersection ID: N/A	Main Street: BALLANTYNE_COMMONS_PY	Cross Street: N/A	Location:	NE
ADA ID: 4E6BDA311337	Ramp Type: Perp	Initial Pass/Fail: Fail	Overall Compliance: No	Severity Score: 12.5

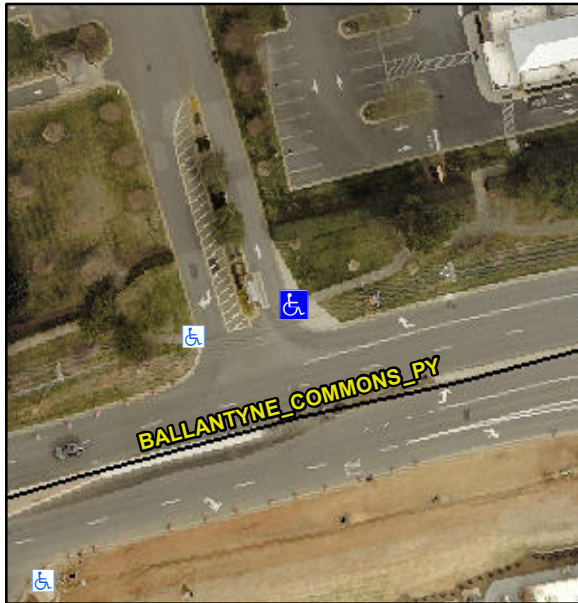
**Not Found, R304.2.2**

Compliance	Description	Data	Compliance	Description	Data
N/A	Ramp Length (in)	48.0	No	Ramp Slope (%)	9.2
Yes	Ramp Width (in)	60.0	Yes	Ramp XSlope (%)	0.4
N/A	Flare Type LT	N/A	N/A	Flare Type RT	N/A
N/A	Flare Slope LT (%)	N/A	N/A	Flare Slope RT (%)	N/A
N/A	Flare Traversable LT?	N/A	N/A	Flare Traversable RT?	N/A
N/A	Landing Length (in)	N/A	N/A	DWS Provided?	N/A
N/A	Landing Width (in)	N/A	N/A	DWS Contrast?	N/A
N/A	Landing Slope (%)	N/A	N/A	DWS Length (in)	N/A
N/A	Landing X Slope (%)	N/A	N/A	DWS Full Width?	N/A
N/A	Landing Curb? (Y/N)	N/A	N/A	DWS Offset (in)	N/A
N/A	Shared Landing?	N/A			
N/A	Gutter Ponding?	N/A	N/A	Gutter Slope (%)	N/A
N/A	Gutter Lip Ht (in)	N/A	N/A	Gutter X Slope (%)	N/A
N/A	Painted X Walk1?	No	N/A	Painted X Walk2?	N/A
	X Walk 1 Direction	To W		X Walk 2 Direction	N/A
N/A	X Walk 1 Width (in)	N/A	N/A	X Walk 2 Width (in)	N/A
	X Walk 1 Slope (%)	0.2		X Walk 2 Slope (%)	N/A
	X Walk 1 X Slope (%)	0.3		X Walk 2 X Slope (%)	N/A

### Possible Solutions:

### Remove & Replace Entire Ramp.
