# Access Compliance Report

## Public Rights-of-Way

### (Curb Ramps)

Intersection ID: 11691	Main Street: E_18TH_ST	Cross Street: N_MCDOWELL_ST	Location: W
ADA ID: 4E77079476D2	Ramp Type: PerpDiag	Initial Pass/Fail: Fail	Overall Compliance: No
		Severity Score: 35

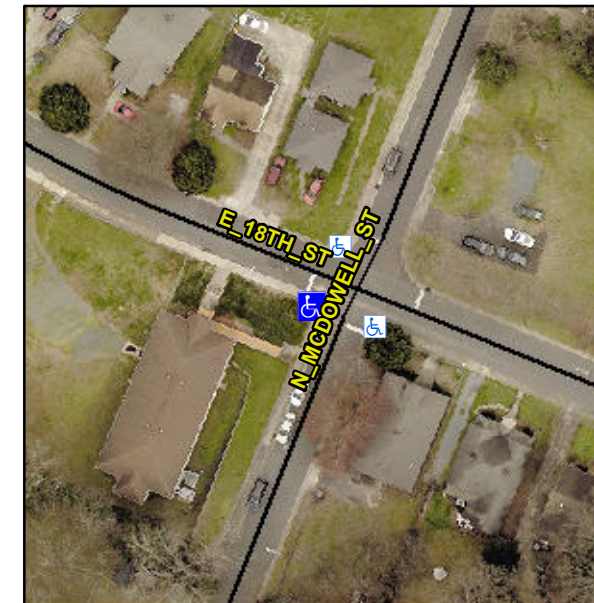
Compliance	Description	Data	Compliance	Description	Data
N/A	Ramp Length (in)	62.0	No	Ramp Slope (%)	12.2
No	Ramp Width (in)	47.5	No	Ramp XSlope (%)	4.6
N/A	Flare Type LT	N/A	N/A	Flare Type RT	N/A
N/A	Flare Slope LT (%)	N/A	N/A	Flare Slope RT (%)	N/A
N/A	Flare Traversable LT?	N/A	N/A	Flare Traversable RT?	N/A
N/A	Landing Length (in)	N/A	N/A	DWS Provided?	N/A
N/A	Landing Width (in)	N/A	N/A	DWS Contrast?	N/A
N/A	Landing Slope (%)	N/A	N/A	DWS Length (in)	N/A
N/A	Landing X Slope (%)	N/A	N/A	DWS Full Width?	N/A
N/A	Landing Curb? (Y/N)	N/A	N/A	DWS Offset (in)	N/A
N/A	Shared Landing?	N/A			
N/A	Gutter Ponding?	N/A	N/A	Gutter Slope (%)	N/A
N/A	Gutter Lip Ht (in)	N/A	N/A	Gutter X Slope (%)	N/A
N/A	Painted X Walk1?	No	N/A	Painted X Walk2?	No
	X Walk 1 Direction	To SE		X Walk 2 Direction	To NE
N/A	X Walk 1 Width (in)	N/A	N/A	X Walk 2 Width (in)	N/A
	X Walk 1 Slope (%)	7.4		X Walk 2 Slope (%)	1.1
	X Walk 1 X Slope (%)	0.7		X Walk 2 X Slope (%)	6.7

N/A	Ramp inside XWalk1?	N/A	N/A	Ramp inside XWalk2?	N/A
	Road Slope (%)	0.3	N/A	Clear Space?	N/A
	Road X Slope (%)	4.6	N/A	Clear Space to XWalk (in)	N/A
N/A	Any Obstructions?	N/A	N/A	Storm Grate/Utility Hazard?	N/A
	Obstruction Type			Storm Grate/Utility Type	
		N/A			N/A
			Yes	Surface Condition? (G/P)	Good

**Remove & Replace Curb Ramp With Two New Directional Ramps or Equivalent.**
