# Access Compliance Report

## Public Rights-of-Way

### (Curb Ramps)

Intersection ID: 10020762	Main Street: BEATTIES_FORD_RD	Cross Street: N/A	Location: NE
ADA ID: 4E7C340A7008	Ramp Type: Para	Initial Pass/Fail: Fail	Overall Compliance: No
			Severity Score: 13.75

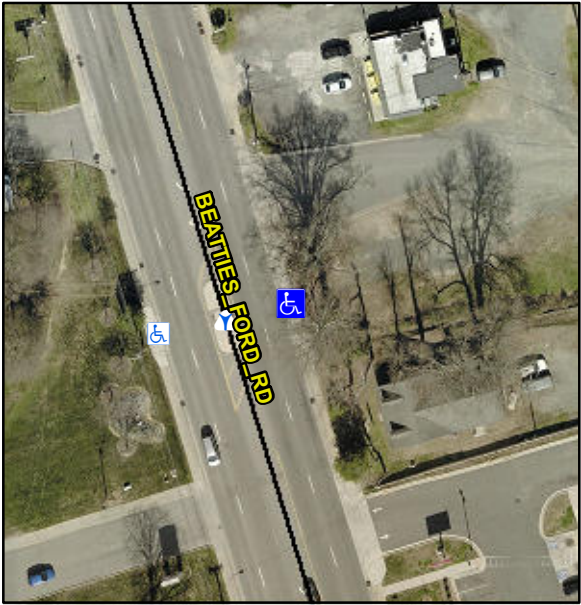
Possible Solutions:		<b>Compliance</b>	<b>Description</b>	<b>Data</b>
	<b>Remove &amp; Replace Entire Ramp.</b>		<b>N/A</b>	Ramp Length LT (in)	<b>82.0</b>
			<b>Yes</b>	Ramp Width LT (in)	<b>77.0</b>
			<b>Yes</b>	Ramp Slope LT (%)	<b>5.6</b>
			<b>No</b>	Ramp XSlope LT (%)	<b>2.3</b>
			<b>N/A</b>	Landing Length (in)	<b>N/A</b>
			<b>N/A</b>	Landing Width (in)	<b>N/A</b>
			<b>N/A</b>	Landing Slope (%)	<b>N/A</b>
			<b>N/A</b>	Landing X Slope (%)	<b>N/A</b>
			<b>N/A</b>	Landing Curb? (Y/N)	<b>N/A</b>
<p>Surveyor Notes:</p> <p><b>N/A</b></p> <p>PROW/ADA:</p> <p><b>R304.5.3, R304.3.2</b></p>			<b>N/A</b>	Ramp XSlope RT (%)	<b>1.6</b>
			<b>N/A</b>	Ramp Length RT (in)	<b>77.0</b>
			<b>Yes</b>	Ramp Width RT (in)	<b>77.0</b>
			<b>No</b>	Ramp Slope RT (%)	<b>9.1</b>
			<b>Yes</b>	Ramp XSlope RT (%)	<b>1.6</b>
			<b>N/A</b>	DWS Provided?	<b>N/A</b>

<b>N/A</b>	DWS Contrast?	<b>N/A</b>
			<b>N/A</b>	DWS Length (in)	<b>N/A</b>
			<b>N/A</b>	DWS Full Width?	<b>N/A</b>
			<b>N/A</b>	DWS Offset (in)	<b>N/A</b>
			<b>N/A</b>	Gutter Slope (%)	<b>N/A</b>
			<b>N/A</b>	Gutter X Slope (%)	<b>N/A</b>
			<b>N/A</b>	Painted X Walk1?	<b>N/A</b>
			<b>No</b>	Painted X Walk2?	<b>N/A</b>
			<b>To SW</b>	X Walk 1 Direction	<b>N/A</b>
			<b>N/A</b>	X Walk 1 Width (in)	<b>N/A</b>
			<b>3.6</b>	X Walk 1 Slope (%)	<b>N/A</b>
			<b>0.7</b>	X Walk 1 X Slope (%)	<b>N/A</b>
			<b>N/A</b>	Ramp inside XWalk1?	<b>N/A</b>
			<b>N/A</b>	Ramp inside XWalk2?	<b>N/A</b>
			<b>N/A</b>	Clear Space?	<b>N/A</b>
			<b>N/A</b>	Clear Space to XWalk (in)	<b>N/A</b>
			<b>N/A</b>	Storm Grate/Utility Hazard?	<b>N/A</b>
				Storm Grate/Utility Type	
			<b>N/A</b>		<b>N/A</b>
			<b>Yes</b>	Surface Condition? (G/P)	<b>Good</b>
			<b>N/A</b>	Curb Slope (%)	<b>7.2</b>
Total Cost:		\$ 1600.00
