Access Compliance Report

Public Rights-of-Way

(Curb Ramps)

Intersection ID: 5574	Main Street: BANNER_ELK_DR	Cross Street: SUNSET_RD	Location: SW
ADA ID: 4E7F10391CC7	Ramp Type: Perp	Initial Pass/Fail: Fail	Overall Compliance: No
Codes/Mitigation Info/Possible Solution		Field Measurements/Component Compliance	
Severity Score: 21.25

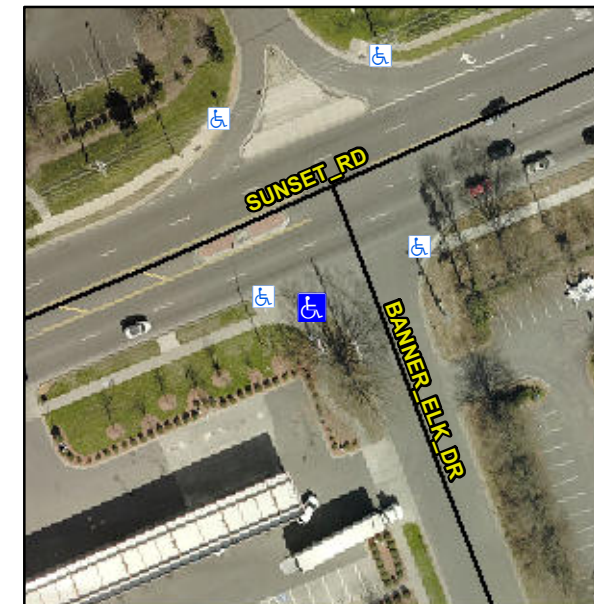
Not Found, R304.5.1, R304.2.2

Compliance	Description	Data	Compliance	Description	Data
N/A	Ramp Length (in)	91.0	No	Ramp Slope (%)	8.4
No	Ramp Width (in)	47.0	Yes	Ramp XSlope (%)	1.9
N/A	Flare Type LT	N/A	N/A	Flare Type RT	N/A
N/A	Flare Slope LT (%)	N/A	N/A	Flare Slope RT (%)	N/A
N/A	Flare Traversable LT?	N/A	N/A	Flare Traversable RT?	N/A
N/A	Landing Length (in)	N/A	N/A	DWS Provided?	N/A
N/A	Landing Width (in)	N/A	N/A	DWS Contrast?	N/A
N/A	Landing Slope (%)	N/A	N/A	DWS Length (in)	N/A
N/A	Landing X Slope (%)	N/A	N/A	DWS Full Width?	N/A
N/A	Landing Curb? (Y/N)	N/A	N/A	DWS Offset (in)	N/A
N/A	Shared Landing?	N/A			
N/A	Gutter Ponding?	N/A	N/A	Gutter Slope (%)	N/A
N/A	Gutter Lip Ht (in)	N/A	N/A	Gutter X Slope (%)	N/A
N/A	Painted X Walk1?	No	N/A	Painted X Walk2?	N/A
	X Walk 1 Direction	To E		X Walk 2 Direction	N/A
N/A	X Walk 1 Width (in)	N/A	N/A	X Walk 2 Width (in)	N/A
	X Walk 1 Slope (%)	1.5		X Walk 2 Slope (%)	N/A
	X Walk 1 X Slope (%)	1.9		X Walk 2 X Slope (%)	N/A

N/A	Ramp inside XWalk1?	N/A	N/A	Ramp inside XWalk2?	N/A
	Road Slope (%)	N/A	N/A	Clear Space?	N/A
	Road X Slope (%)	N/A	N/A	Clear Space to XWalk (in)	N/A
N/A	Any Obstructions?	N/A	N/A	Storm Grate/Utility Hazard?	N/A
	Obstruction Type			Storm Grate/Utility Type	
		N/A			N/A
			Yes	Surface Condition? (G/P)	Good

Possible Solutions:

Remove & Replace Entire Ramp.

Total Cost: \$ 1850.00
