## Access Compliance Report Public Rights-of-Way (Curb Ramps)

Intersection ID: 42914 Main Street: CROSSWALK\_DR Cross Street: FOREST\_CROSS\_DR Location: E

ADA ID: 4E8AB26F2728 Ramp Type: PerpDiag Initial Pass/Fail: Fail Overall Compliance: No Severity Score: 8.75

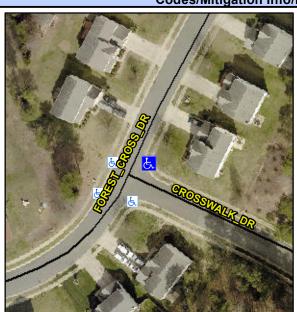
Not Found, R304.5.1

Tiola modear officines of officine of officine							
	Compliance Description		Data	Compli	ance	Description	Data
	N/A	Ramp Length (in)	50.0	Yes	Ramp	Slope (%)	6.1
	No	Ramp Width (in)	44.5	Yes	Ramp	XSlope (%)	0.8
	N/A	Flare Type LT	N/A	N/A	Flare	Type RT	N/A
	N/A	Flare Slope LT (%)	N/A	N/A	Flare	Slope RT (%)	N/A
	N/A	Flare Traversable LT?	N/A	N/A	Flare	Traversable RT?	N/A
	N/A	Landing Length (in)	N/A	N/A	DWS	Provided?	N/A
	N/A	Landing Width (in)	N/A	N/A	DWS	Contrast?	N/A
	N/A	Landing Slope (%)	N/A	N/A	DWS	Length (in)	N/A
	N/A	Landing X Slope (%)	N/A	N/A	DWS	Full Width?	N/A
	N/A	Landing Curb? (Y/N)	N/A	N/A	DWS	Offset (in)	N/A
	N/A	Shared Landing?	N/A				
	N/A	Gutter Ponding?	N/A	N/A	Gutte	r Slope (%)	N/A
	N/A	Gutter Lip Ht (in)	N/A	N/A	Gutte	r X Slope (%)	N/A
	N/A	Painted X Walk1?	No	N/A	Painte	ed X Walk2?	No
		X Walk 1 Direction	To NW		X Wa	lk 2 Direction	To SW
	N/A	X Walk 1 Width (in)	N/A	N/A	X Wa	lk 2 Width (in)	N/A

X Walk 1 Slope (%)	2.0		X Wa	lk 2 Slope (%)	0.2
		X Walk 1 X Slope (%)	0.3		X Wa	lk 2 X Slope (%)	0.4
	N/A	Ramp inside XWalk1?	N/A	N/A	Ramp	inside XWalk2?	N/A
		Road Slope (%)	0.0	N/A	Clear	Space?	N/A
		Road X Slope (%)	0.9	N/A	Clear	Space to XWalk (in)	N/A

Remove & Replace Curb Ramp With Two New Directional Ramps or Equivalent.
