Access Compliance Report

Public Rights-of-Way

(Curb Ramps)

Intersection ID: 10021121	Main Street: BEVINGTON_PL	Cross Street: MITCHELL_HOLLOW_RD	Location: NE
ADA ID: 4E944A624706	Ramp Type: PerpDiag	Initial Pass/Fail: Fail	Overall Compliance: No
Severity Score: 21.25			
Codes/Mitigation Info/Possible Solution		Field Measurements/Component Compliance

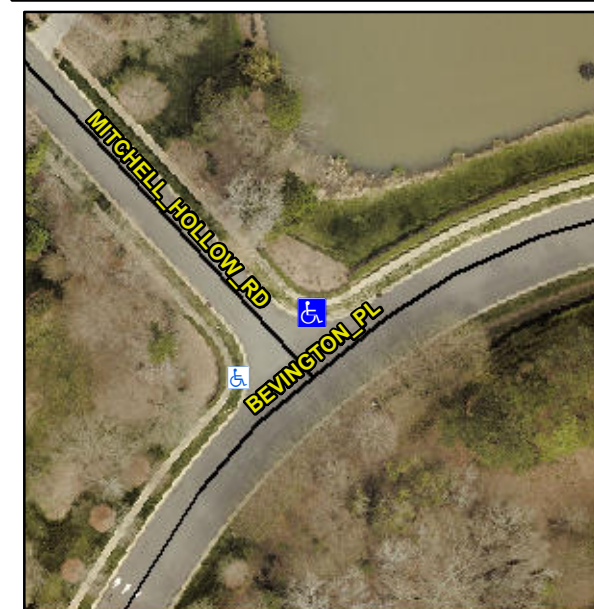
Not Found, R304.5.1, R304.2.2

Compliance	Description	Data	Compliance	Description	Data
N/A	Ramp Length (in)	68.0	No	Ramp Slope (%)	8.4
No	Ramp Width (in)	47.0	Yes	Ramp XSlope (%)	1.9
N/A	Flare Type LT	N/A	N/A	Flare Type RT	N/A
N/A	Flare Slope LT (%)	N/A	N/A	Flare Slope RT (%)	N/A
N/A	Flare Traversable LT?	N/A	N/A	Flare Traversable RT?	N/A
N/A	Landing Length (in)	N/A	N/A	DWS Provided?	N/A
N/A	Landing Width (in)	N/A	N/A	DWS Contrast?	N/A
N/A	Landing Slope (%)	N/A	N/A	DWS Length (in)	N/A
N/A	Landing X Slope (%)	N/A	N/A	DWS Full Width?	N/A
N/A	Landing Curb? (Y/N)	N/A	N/A	DWS Offset (in)	N/A
N/A	Shared Landing?	N/A			
N/A	Gutter Ponding?	N/A	N/A	Gutter Slope (%)	N/A
N/A	Gutter Lip Ht (in)	N/A	N/A	Gutter X Slope (%)	N/A
N/A	Painted X Walk1?	No	N/A	Painted X Walk2?	No
	X Walk 1 Direction	To SW		X Walk 2 Direction	To SE
N/A	X Walk 1 Width (in)	N/A	N/A	X Walk 2 Width (in)	N/A
	X Walk 1 Slope (%)	3.0		X Walk 2 Slope (%)	1.3
	X Walk 1 X Slope (%)	2.8		X Walk 2 X Slope (%)	2.3

N/A	Ramp inside XWalk1?	N/A	N/A	Ramp inside XWalk2?	N/A
	Road Slope (%)	3.6	N/A	Clear Space?	N/A
	Road X Slope (%)	1.2	N/A	Clear Space to XWalk (in)	N/A
N/A	Any Obstructions?	N/A	N/A	Storm Grate/Utility Hazard?	N/A
	Obstruction Type			Storm Grate/Utility Type	
		N/A			N/A
		Yes		Surface Condition? (G/P)	Good

Possible Solutions:

Remove & Replace Curb Ramp With Two New Directional Ramps or Equivalent.
