Access Compliance Report Public Rights-of-Way (Curb Ramps)

Intersection ID: 14283 Main Street: AROSA_AV Cross Street: DILWORTH_RD Location: NE ADA ID: 4EA29C3B9010 Ramp Type: Directional1 Initial Pass/Fail: Fail **Overall Compliance: No Severity Score:** 1.25

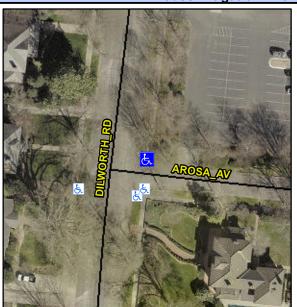
Field Measurements/Component Compliance							
Comp	liance Description	Data	Comp	liance Description	Data		
N/A	Ramp Length (in)	48.0	N/A	Grade Break?	N/A		
Yes	Ramp Width (in)	72.0	N/A	Grade Break Slope (%)	0.0		
Yes	Ramp Slope (%)	5.2	N/A	Grade Break XSlope (%)	0.0		
No	Ramp XSlope (%)	2.9					
N/A	Flare Type LT	N/A	N/A	Flare Type RT	N/A		
N/A	Flare Slope LT (%)	N/A	N/A	Flare Slope RT (%)	0.0		
N/A	Flare Traversable LT?	N/A	N/A	Flare Traversable RT?	N/A		
N/A	Landing Length (in)	0.0	N/A	DWS Provided?	N/A		
N/A	Landing Width (in)	0.0	N/A	DWS Contrast?	N/A		
N/A	Landing Slope (%)	0.0	N/A	DWS Length (in)	N/A		
N/A	Landing X Slope (%)	0.0	N/A	DWS Full Width?	N/A		
N/A	Landing Curb? (Y/N)	N/A	N/A	DWS Offset LT (in)	N/A		
N/A	Shared Landing?	N/A	N/A	DWS Offset RT (in)	N/A		
N/A	Gutter Ponding?	0.0	N/A	Gutter Slope (%)	N/A		
N/A	Gutter Lip Ht (in)	2.0	N/A	Gutter X Slope (%)	N/A		
N/A	Painted X Walk1?	No		Road Slope (%)	0.2

X Walk 1 Direction	To S		Road X Slope (%)	1.1		
	X Walk 1 Width (in)	N/A		Clear Space?	N/A		
	X Walk 1 Slope (%)	0.2	N/A	Clear Space to XWalk (in)	N/A		
	X Walk 1 X Slope (%)	1.1	N/A	Storm Grate/Utility Hazard?	N/A		
N/A	Ramp inside XWalk1?	N/A		Storm Grate/Utility Type			
N/A	Any Obstructions?	N/A			N/A		
	Obstruction Type		Yes	Surface Condition? (G/P)	Good		
		N/A	N/A	Curb Slope (%)	5.3

Possible Solutions:
Remove & Replace Entire Ramp.
Surveyor Notes:
N/A
N/A
PROW/ADA:
R304.5.3

Curreyor rector.		
N/A		N/A
		N/A
		N/A
		N/A
PROW/ADA:		N/A
R304.5.3		N/A
		N/A N/A
Total Cost:	\$ 1600.00
