Access Compliance Report

Public Rights-of-Way

(Curb Ramps)

Intersection ID: 21789	Main Street: THORNCLIFF_DR	Cross Street: WOODSTOCK_DR	Location:	N
ADA ID: 4EA34D9C5A32	Ramp Type: PerpDiag	Initial Pass/Fail: Fail	Overall Compliance: No	Severity Score: 1.25
Codes/Mitigation Info/Possible Solution		Field Measurements/Component Compliance

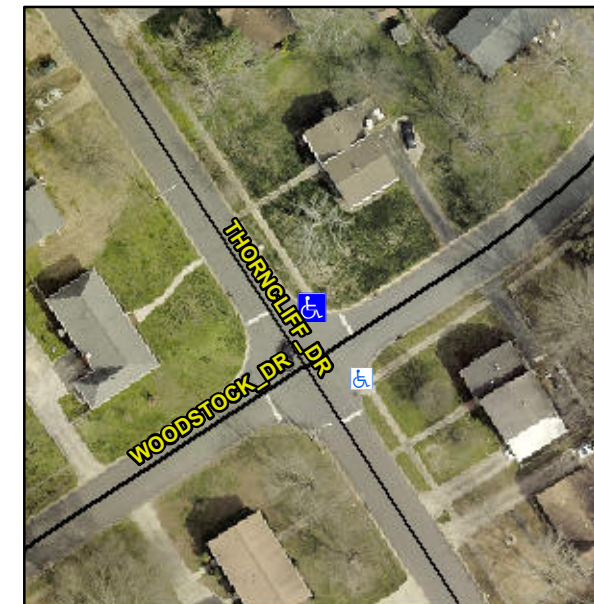
Not Found, R304.5.3

Compliance	Description	Data	Compliance	Description	Data
N/A	Ramp Length (in)	40.0	Yes	Ramp Slope (%)	7.2
Yes	Ramp Width (in)	55.0	No	Ramp XSlope (%)	3.1
N/A	Flare Type LT	N/A	N/A	Flare Type RT	N/A
N/A	Flare Slope LT (%)	N/A	N/A	Flare Slope RT (%)	N/A
N/A	Flare Traversable LT?	N/A	N/A	Flare Traversable RT?	N/A
N/A	Landing Length (in)	N/A	N/A	DWS Provided?	N/A
N/A	Landing Width (in)	N/A	N/A	DWS Contrast?	N/A
N/A	Landing Slope (%)	N/A	N/A	DWS Length (in)	N/A
N/A	Landing X Slope (%)	N/A	N/A	DWS Full Width?	N/A
N/A	Landing Curb? (Y/N)	N/A	N/A	DWS Offset (in)	N/A
N/A	Shared Landing?	N/A			
N/A	Gutter Ponding?	N/A	N/A	Gutter Slope (%)	N/A
N/A	Gutter Lip Ht (in)	N/A	N/A	Gutter X Slope (%)	N/A
N/A	Painted X Walk1?	No	N/A	Painted X Walk2?	No
	X Walk 1 Direction	To SW		X Walk 2 Direction	To SE
N/A	X Walk 1 Width (in)	N/A	N/A	X Walk 2 Width (in)	N/A
	X Walk 1 Slope (%)	4.2		X Walk 2 Slope (%)	0.9
	X Walk 1 X Slope (%)	0.2		X Walk 2 X Slope (%)	3.4

N/A	Ramp inside XWalk1?	N/A	N/A	Ramp inside XWalk2?	N/A
	Road Slope (%)	2.4	N/A	Clear Space?	N/A
	Road X Slope (%)	2.6	N/A	Clear Space to XWalk (in)	N/A
N/A	Any Obstructions?	N/A	N/A	Storm Grate/Utility Hazard?	N/A
	Obstruction Type			Storm Grate/Utility Type	
		N/A			N/A
		Yes		Surface Condition? (G/P)	Good

Remove & Replace Curb Ramp With Two New Directional Ramps or Equivalent.
