# Access Compliance Report

## Public Rights-of-Way

### (Curb Ramps)

Intersection ID: 47818	Main Street: ROYAL_FERN_LN	Cross Street: ROCKMOOR_RIDGE_RD	Location: SW
ADA ID: 4EAAD7D63BFD	Ramp Type: PerpDiag	Initial Pass/Fail: Fail	Overall Compliance: No
Severity Score: 37.5			
Codes/Mitigation Info/Possible Solution		Field Measurements/Component Compliance

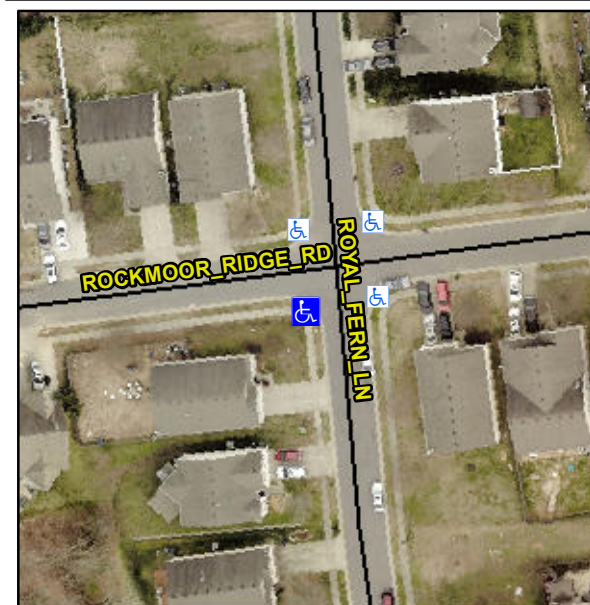
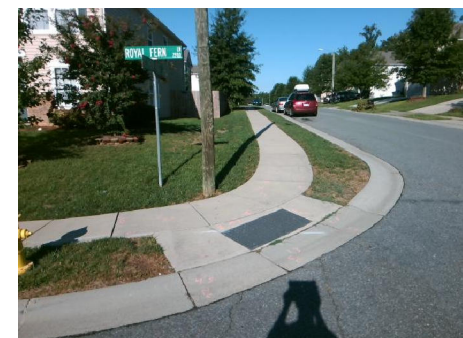
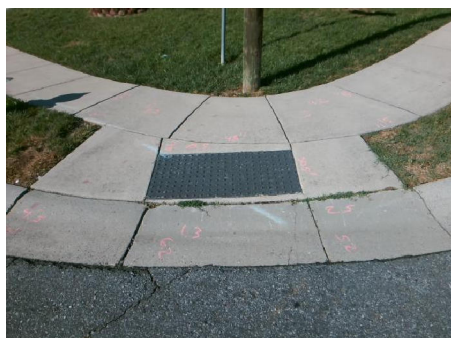
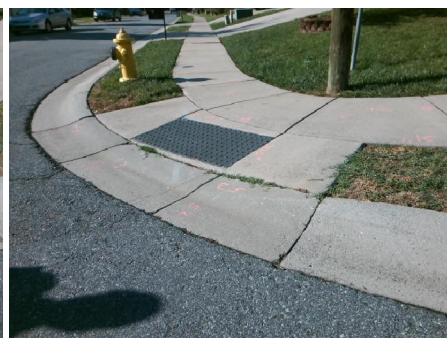
**Not Found, R304.2.2, R304.5.3**

Compliance	Description	Data	Compliance	Description	Data
N/A	Ramp Length (in)	30.5	No	Ramp Slope (%)	9.0
Yes	Ramp Width (in)	48.0	No	Ramp XSlope (%)	8.5
N/A	Flare Type LT	N/A	N/A	Flare Type RT	N/A
N/A	Flare Slope LT (%)	N/A	N/A	Flare Slope RT (%)	N/A
N/A	Flare Traversable LT?	N/A	N/A	Flare Traversable RT?	N/A
N/A	Landing Length (in)	N/A	N/A	DWS Provided?	N/A
N/A	Landing Width (in)	N/A	N/A	DWS Contrast?	N/A
N/A	Landing Slope (%)	N/A	N/A	DWS Length (in)	N/A
N/A	Landing X Slope (%)	N/A	N/A	DWS Full Width?	N/A
N/A	Landing Curb? (Y/N)	N/A	N/A	DWS Offset (in)	N/A
N/A	Shared Landing?	N/A			
N/A	Gutter Ponding?	N/A	N/A	Gutter Slope (%)	N/A
N/A	Gutter Lip Ht (in)	N/A	N/A	Gutter X Slope (%)	N/A
N/A	Painted X Walk1?	No	N/A	Painted X Walk2?	No
	X Walk 1 Direction	To E		X Walk 2 Direction	To N
N/A	X Walk 1 Width (in)	N/A	N/A	X Walk 2 Width (in)	N/A
	X Walk 1 Slope (%)	2.6		X Walk 2 Slope (%)	5.2
	X Walk 1 X Slope (%)	4.3		X Walk 2 X Slope (%)	2.5

N/A	Ramp inside XWalk1?	N/A	N/A	Ramp inside XWalk2?	N/A
	Road Slope (%)	6.2	N/A	Clear Space?	N/A
	Road X Slope (%)	1.3	N/A	Clear Space to XWalk (in)	N/A
N/A	Any Obstructions?	N/A	N/A	Storm Grate/Utility Hazard?	N/A
	Obstruction Type			Storm Grate/Utility Type	
		N/A			N/A
			Yes	Surface Condition? (G/P)	Good

**Remove & Replace Curb Ramp With Two New Directional Ramps or Equivalent.**

Total Cost: \$ **3200.00**
