Access Compliance Report

Public Rights-of-Way

(Curb Ramps)

Intersection ID: 19947	Main Street: CHARTER_PL	Cross Street: THERMAL_RD	Location:	N
ADA ID: 4EAE84DFC264	Ramp Type: BlendTrans2	Initial Pass/Fail: Fail	Overall Compliance: No	Severity Score: 10

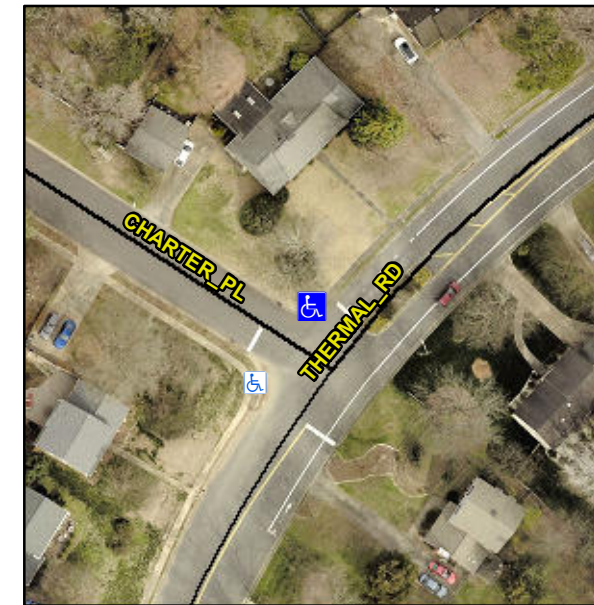
Not Found, R304.5.1, R304.5.3

Compliance	Description	Data	Compliance	Description	Data
N/A	Ramp Length (in)	38.0	Yes	BlendTrans Slope (%)	2.4
No	Ramp Width (in)	46.0	No	BlendTrans XSlope (%)	3.3
N/A	Flare Type LT	N/A	N/A	Flare Type RT	N/A
N/A	Flare Slope LT (%)	N/A	N/A	Flare Slope RT (%)	N/A
N/A	Flare Traversable LT?	N/A	N/A	Flare Traversable RT?	N/A
N/A	Landing Length (in)	N/A	N/A	DWS Provided?	N/A
N/A	Landing Width (in)	N/A	N/A	DWS Contrast?	N/A
N/A	Landing Slope (%)	N/A	N/A	DWS Length (in)	N/A
N/A	Landing X Slope (%)	N/A	N/A	DWS Full Width?	N/A
N/A	Landing Curb? (Y/N)	N/A	N/A	DWS Offset (in)	N/A
N/A	Shared Landing?	N/A			
N/A	Gutter Ponding?	N/A	N/A	Gutter Slope (%)	N/A
N/A	Gutter Lip Ht (in)	N/A	N/A	Gutter X Slope (%)	N/A
N/A	Painted X Walk1?	No	N/A	Painted X Walk2?	No
	X Walk 1 Direction	To SW		X Walk 2 Direction	To SE
	X Walk 1 Width (in)	N/A		X Walk 2 Width (in)	N/A
	X Walk 1 Slope (%)	5.4		X Walk 2 Slope (%)	1.9
	X Walk 1 X Slope (%)	2.0		X Walk 2 X Slope (%)	5.2

N/A	Ramp inside XWalk1?	N/A	N/A	Ramp inside XWalk2?	N/A
	Road Slope (%)	3.5		Clear Space?	N/A
	Road X Slope (%)	4.3	N/A	Clear Space to XWalk (in)	N/A
N/A	Any Obstructions?	N/A	N/A	Storm Grate/Utility Hazard?	N/A
	Obstruction Type			Storm Grate/Utility Type	
		N/A			N/A
			Yes	Surface Condition? (G/P)	Good
			No	Curb Slope (%)	14.5

Remove & Replace Curb Ramp With Two New Directional Ramps or Equivalent.
