Access Compliance Report

Public Rights-of-Way

(Curb Ramps)

Intersection ID: N/A	Main Street: CLANTON_RD	Cross Street: I-77_TO_CLANTON_RD	Location: SW
ADA ID: 4EB9386A0470	Ramp Type: Perp	Initial Pass/Fail: Fail	Overall Compliance: No
		Severity Score: 8.75

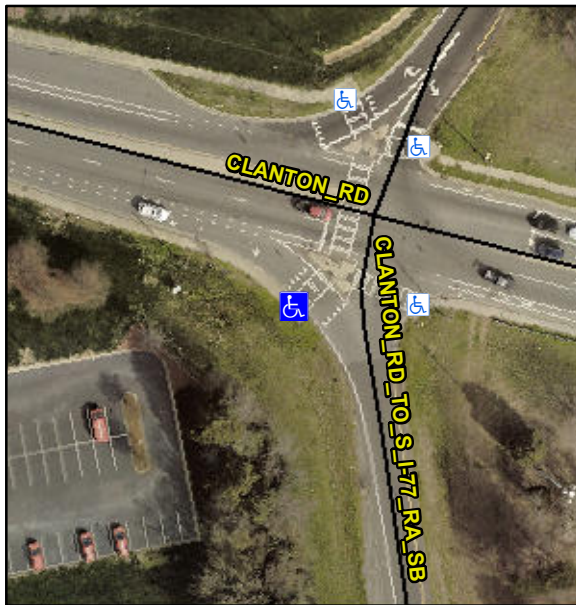
Not Found, R304.5.1

Compliance	Description	Data	Compliance	Description	Data
N/A	Ramp Length (in)	27.5	Yes	Ramp Slope (%)	5.3
No	Ramp Width (in)	47.0	Yes	Ramp XSlope (%)	0.2
N/A	Flare Type LT	N/A	N/A	Flare Type RT	N/A
N/A	Flare Slope LT (%)	N/A	N/A	Flare Slope RT (%)	N/A
N/A	Flare Traversable LT?	N/A	N/A	Flare Traversable RT?	N/A
N/A	Landing Length (in)	N/A	N/A	DWS Provided?	N/A
N/A	Landing Width (in)	N/A	N/A	DWS Contrast?	N/A
N/A	Landing Slope (%)	N/A	N/A	DWS Length (in)	N/A
N/A	Landing X Slope (%)	N/A	N/A	DWS Full Width?	N/A
N/A	Landing Curb? (Y/N)	N/A	N/A	DWS Offset (in)	N/A
N/A	Shared Landing?	N/A			
N/A	Gutter Ponding?	N/A	N/A	Gutter Slope (%)	N/A
N/A	Gutter Lip Ht (in)	N/A	N/A	Gutter X Slope (%)	N/A
N/A	Painted X Walk1?	Yes	N/A	Painted X Walk2?	N/A
	X Walk 1 Direction	To NE		X Walk 2 Direction	N/A
N/A	X Walk 1 Width (in)	110.5	N/A	X Walk 2 Width (in)	N/A
	X Walk 1 Slope (%)	4.4		X Walk 2 Slope (%)	N/A
	X Walk 1 X Slope (%)	0.7		X Walk 2 X Slope (%)	N/A

N/A	Ramp inside XWalk1?	Yes	N/A	Ramp inside XWalk2?	N/A
	Road Slope (%)	N/A	N/A	Clear Space?	N/A
	Road X Slope (%)	N/A	N/A	Clear Space to XWalk (in)	N/A
N/A	Any Obstructions?	N/A	N/A	Storm Grate/Utility Hazard?	N/A
	Obstruction Type			Storm Grate/Utility Type	
		N/A			N/A
			Yes	Surface Condition? (G/P)	Good

Remove & Replace Entire Ramp.
