Access Compliance Report

Public Rights-of-Way

(Curb Ramps)

Intersection ID: 26633	Main Street: WEDDINGTON_RD	Cross Street: FINCHER_MEADOWS_LN	Location: NE
ADA ID: 4EBB7C3D35C7	Ramp Type: Perp	Initial Pass/Fail: Fail	Overall Compliance: No
			Severity Score: 13.75

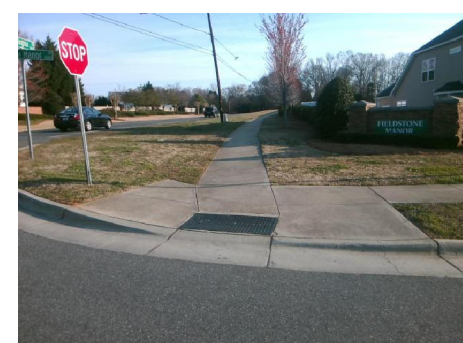
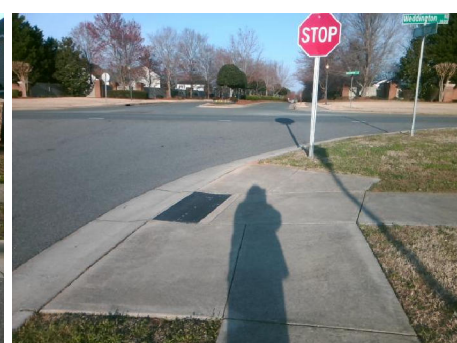
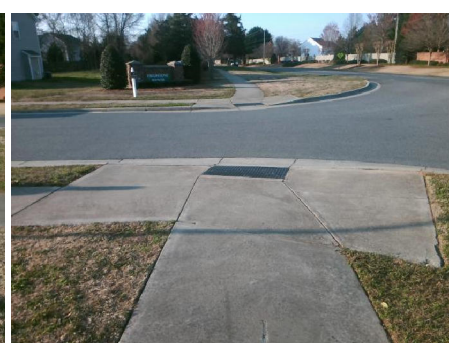
0.1	X Walk 2 Slope (%)	N/A
			5.3	X Walk 2 X Slope (%)	N/A
			N/A	Ramp inside XWalk1?	N/A
			N/A	Ramp inside XWalk2?	N/A
			N/A	Clear Space?	N/A
			N/A	Clear Space to XWalk (in)	N/A
			N/A	Storm Grate/Utility Hazard?	N/A
<p>Obstruction Type</p> <p>N/A</p>			N/A	Storm Grate/Utility Type	N/A
			N/A	Surface Condition? (G/P)	Good
