Access Compliance Report

Public Rights-of-Way

(Curb Ramps)

Intersection ID: 51323	Main Street: GLENMORE_GARDEN_DR	Cross Street: MCKEE_RD	Location: SE
ADA ID: 4ECF74B74830	Ramp Type: Perp	Initial Pass/Fail: Fail	Overall Compliance: No
Codes/Mitigation Info/Possible Solution			Severity Score: 22.5
			Field Measurements/Component Compliance

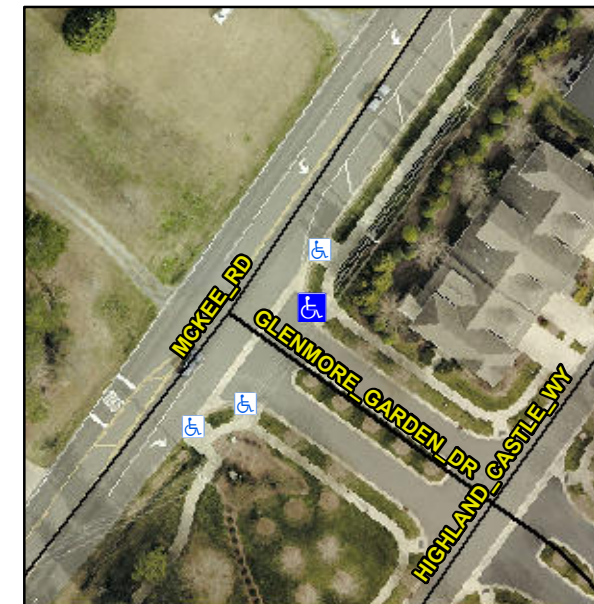
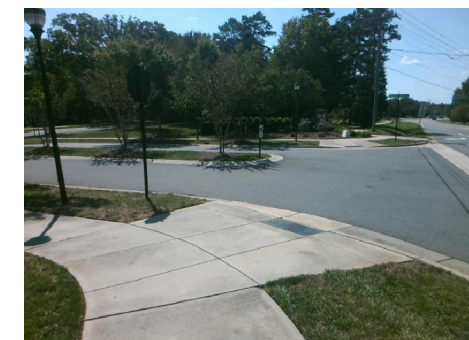
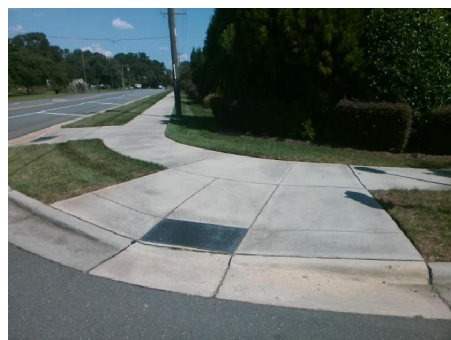
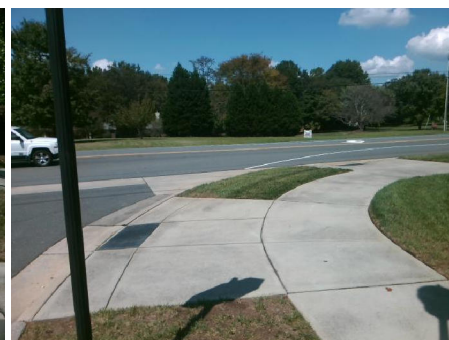
R304.5.1, R304.2.2, R304.5.3

Compliance	Description	Data	Compliance	Description	Data
N/A	Ramp Length (in)	97.0	No	Ramp Slope (%)	8.7
No	Ramp Width (in)	46.0	No	Ramp XSlope (%)	2.6
N/A	Flare Type LT	N/A	N/A	Flare Type RT	N/A
N/A	Flare Slope LT (%)	N/A	N/A	Flare Slope RT (%)	N/A
N/A	Flare Traversable LT?	N/A	N/A	Flare Traversable RT?	N/A
N/A	Landing Length (in)	N/A	N/A	DWS Provided?	N/A
N/A	Landing Width (in)	N/A	N/A	DWS Contrast?	N/A
N/A	Landing Slope (%)	N/A	N/A	DWS Length (in)	N/A
N/A	Landing X Slope (%)	N/A	N/A	DWS Full Width?	N/A
N/A	Landing Curb? (Y/N)	N/A	N/A	DWS Offset (in)	N/A
N/A	Shared Landing?	N/A			
N/A	Gutter Ponding?	N/A	N/A	Gutter Slope (%)	N/A
N/A	Gutter Lip Ht (in)	N/A	N/A	Gutter X Slope (%)	N/A
N/A	Painted X Walk1?	No	N/A	Painted X Walk2?	N/A
	X Walk 1 Direction	To SW		X Walk 2 Direction	N/A
N/A	X Walk 1 Width (in)	N/A	N/A	X Walk 2 Width (in)	N/A
	X Walk 1 Slope (%)	0.8		X Walk 2 Slope (%)	N/A
	X Walk 1 X Slope (%)	3.1		X Walk 2 X Slope (%)	N/A

N/A	Ramp inside XWalk1?	N/A	N/A	Ramp inside XWalk2?	N/A
	Road Slope (%)	N/A	N/A	Clear Space?	N/A
	Road X Slope (%)	N/A	N/A	Clear Space to XWalk (in)	N/A
N/A	Any Obstructions?	N/A	N/A	Storm Grate/Utility Hazard?	N/A
	Obstruction Type			Storm Grate/Utility Type	
		N/A			N/A
			Yes	Surface Condition? (G/P)	Good

Remove & Replace Entire Ramp.

Total Cost: \$ 1850.00
