Access Compliance Report

Public Rights-of-Way

(Curb Ramps)

Intersection ID: 10022109	Main Street: BULFINCH_RD	Cross Street: N/A	Location: S
ADA ID: 4ED65A6990B6	Ramp Type: Perp	Initial Pass/Fail: Fail	Overall Compliance: No
		Severity Score: 12.5

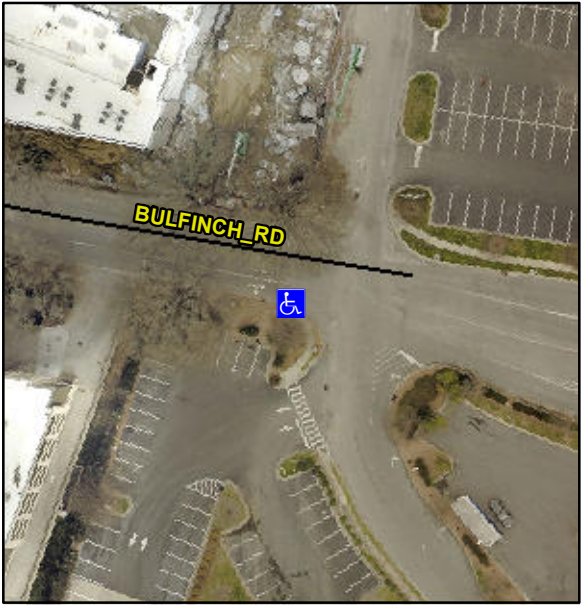
Possible Solutions:		Compliance	Description	Data
	Remove & Replace Entire Ramp.		No	Ramp Length (in)	9.4
			Yes	Ramp Width (in)	0.0
			N/A	Flare Type LT	N/A
			N/A	Flare Slope LT (%)	N/A
			N/A	Flare Traversable LT?	N/A
			N/A	Landing Length (in)	N/A
			N/A	Landing Width (in)	N/A
			N/A	Landing Slope (%)	N/A
			N/A	Landing X Slope (%)	N/A
<p>Surveyor Notes:</p> <p>N/A</p> <p>PROW/ADA:</p> <p>Not Found, R304.2.2</p>			N/A	Flare Type RT	N/A
			N/A	Flare Slope RT (%)	N/A
			N/A	Flare Traversable RT?	N/A
			N/A	DWS Provided?	N/A
			N/A	DWS Contrast?	N/A
			N/A	DWS Length (in)	N/A
			N/A	DWS Full Width?	N/A
			N/A	DWS Offset (in)	N/A
			N/A	Gutter Ponding?	N/A
			N/A	Gutter Lip Ht (in)	N/A
<p>Total Cost:</p> <p>\$ 1850.00</p>			No	Painted X Walk2?	N/A
			To N	X Walk 2 Direction	N/A
			N/A	X Walk 2 Width (in)	N/A

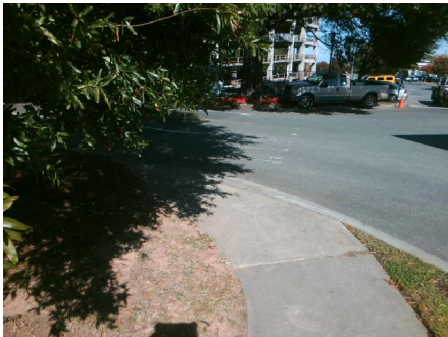
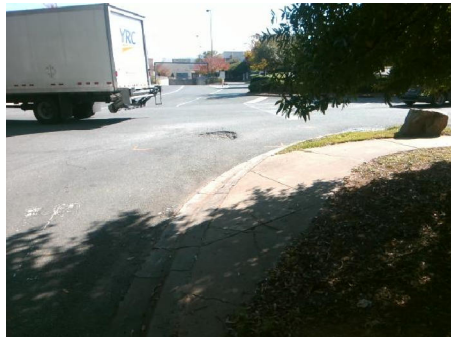
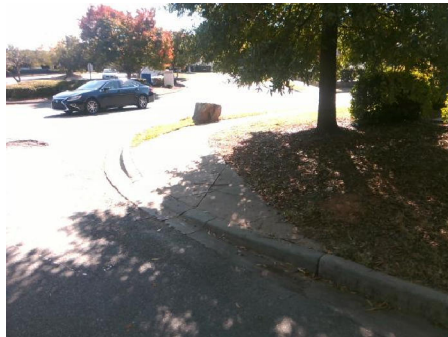
2.8	X Walk 2 Slope (%)	N/A
			1.7	X Walk 2 X Slope (%)	N/A
			N/A	Ramp inside XWalk2?	N/A
			N/A	Clear Space?	N/A
			N/A	Clear Space to XWalk (in)	N/A
			N/A	Storm Grate/Utility Hazard?	N/A
			N/A	Storm Grate/Utility Type	N/A
<p>Street 1 Name</p> <p>BULFINCH RD</p> <p>Stop Condition-Street 2</p> <p>None</p> <p>Street 2 Name</p> <p>N/A</p> <p>Stop Condition-Street 1</p> <p>N/A</p>			N/A	Surface Condition? (G/P)	Good
