Access Compliance Report

Public Rights-of-Way (Curb Ramps)

Intersection ID: N/A	Main Street: HARDING_PL	Cross Street: N/A	Location: SW
ADA ID: 4ED6E7FD7276	Ramp Type: PerpDiag	Initial Pass/Fail: Fail	Overall Compliance: No
		Severity Score: 47.5

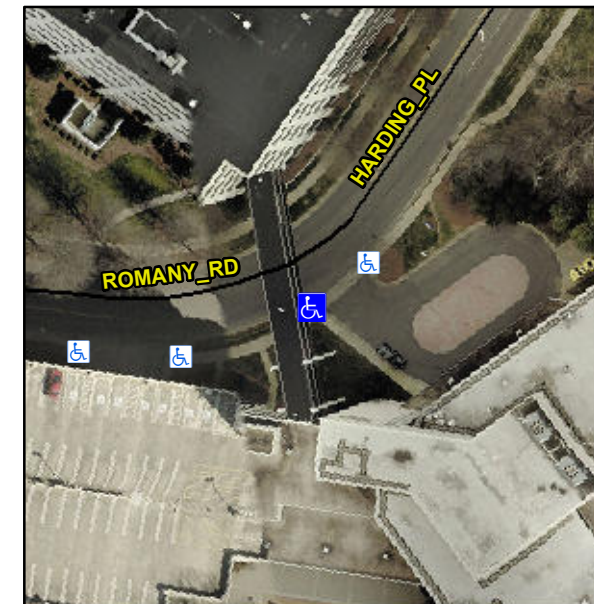
Not Found, R304.5.1, R304.2.2

Compliance	Description	Data	Compliance	Description	Data
N/A	Ramp Length (in)	48.0	No	Ramp Slope (%)	8.4
No	Ramp Width (in)	25.0	Yes	Ramp XSlope (%)	1.1
N/A	Flare Type LT	N/A	N/A	Flare Type RT	N/A
N/A	Flare Slope LT (%)	N/A	N/A	Flare Slope RT (%)	N/A
N/A	Flare Traversable LT?	N/A	N/A	Flare Traversable RT?	N/A
N/A	Landing Length (in)	N/A	N/A	DWS Provided?	N/A
N/A	Landing Width (in)	N/A	N/A	DWS Contrast?	N/A
N/A	Landing Slope (%)	N/A	N/A	DWS Length (in)	N/A
N/A	Landing X Slope (%)	N/A	N/A	DWS Full Width?	N/A
N/A	Landing Curb? (Y/N)	N/A	N/A	DWS Offset (in)	N/A
N/A	Shared Landing?	N/A			
N/A	Gutter Ponding?	N/A	N/A	Gutter Slope (%)	N/A
N/A	Gutter Lip Ht (in)	N/A	N/A	Gutter X Slope (%)	N/A
N/A	Painted X Walk1?	No	N/A	Painted X Walk2?	No
	X Walk 1 Direction	To E		X Walk 2 Direction	To NW
N/A	X Walk 1 Width (in)	N/A	N/A	X Walk 2 Width (in)	N/A
	X Walk 1 Slope (%)	1.2		X Walk 2 Slope (%)	2.8
	X Walk 1 X Slope (%)	9.9		X Walk 2 X Slope (%)	3.5

N/A	Ramp inside XWalk1?	N/A	N/A	Ramp inside XWalk2?	N/A
	Road Slope (%)	3.2	N/A	Clear Space?	N/A
	Road X Slope (%)	6.1	N/A	Clear Space to XWalk (in)	N/A
N/A	Any Obstructions?	N/A	N/A	Storm Grate/Utility Hazard?	N/A
	Obstruction Type			Storm Grate/Utility Type	
		N/A			N/A
			Yes	Surface Condition? (G/P)	Good

Remove & Replace Curb Ramp With Two New Directional Ramps or Equivalent.
