Access Compliance Report

Public Rights-of-Way

(Curb Ramps)

Intersection ID: 12134	Main Street: MARLOWE_AV	Cross Street: BERRYHILL_RD	Location: NE
ADA ID: 4EE37737E813	Ramp Type: Perp	Initial Pass/Fail: Fail	Overall Compliance: No
Severity Score: 10			
Codes/Mitigation Info/Possible Solution		Field Measurements/Component Compliance

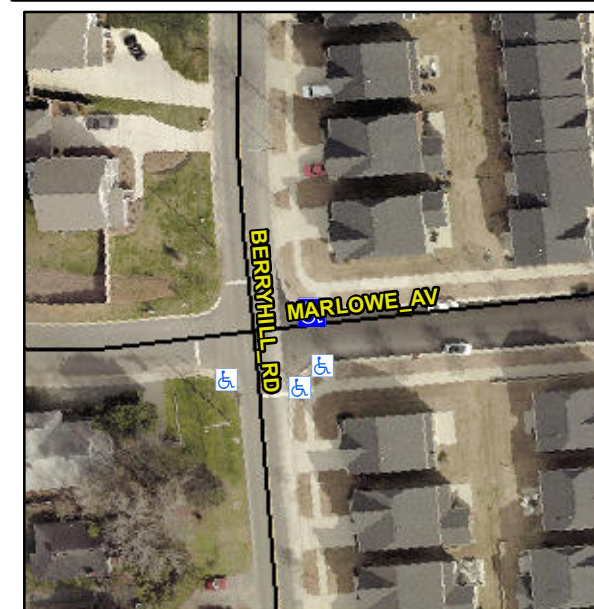
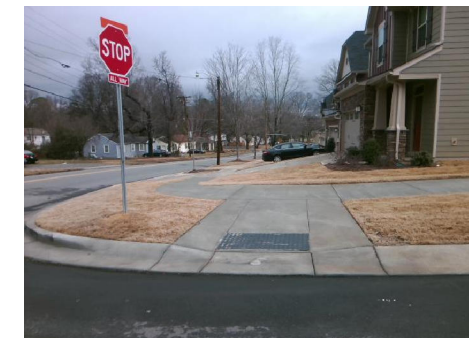
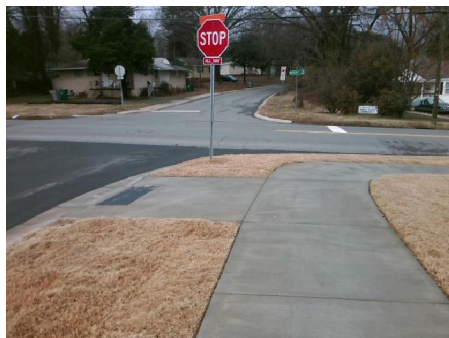
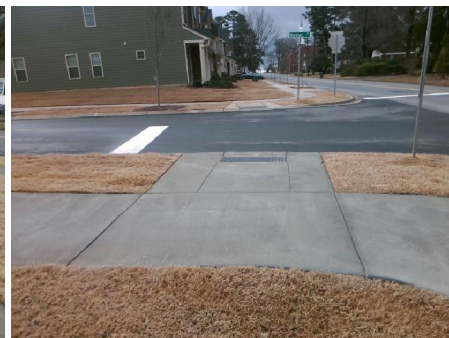
Not Found, R304.5.1, R304.5.3

Compliance	Description	Data	Compliance	Description	Data
N/A	Ramp Length (in)	104.0	Yes	Ramp Slope (%)	5.7
No	Ramp Width (in)	44.5	No	Ramp XSlope (%)	2.9
N/A	Flare Type LT	N/A	N/A	Flare Type RT	N/A
N/A	Flare Slope LT (%)	N/A	N/A	Flare Slope RT (%)	N/A
N/A	Flare Traversable LT?	N/A	N/A	Flare Traversable RT?	N/A
N/A	Landing Length (in)	N/A	N/A	DWS Provided?	N/A
N/A	Landing Width (in)	N/A	N/A	DWS Contrast?	N/A
N/A	Landing Slope (%)	N/A	N/A	DWS Length (in)	N/A
N/A	Landing X Slope (%)	N/A	N/A	DWS Full Width?	N/A
N/A	Landing Curb? (Y/N)	N/A	N/A	DWS Offset (in)	N/A
N/A	Shared Landing?	N/A			
N/A	Gutter Ponding?	N/A	N/A	Gutter Slope (%)	N/A
N/A	Gutter Lip Ht (in)	N/A	N/A	Gutter X Slope (%)	N/A
N/A	Painted X Walk1?	No	N/A	Painted X Walk2?	N/A
	X Walk 1 Direction	To S		X Walk 2 Direction	N/A
N/A	X Walk 1 Width (in)	N/A	N/A	X Walk 2 Width (in)	N/A
	X Walk 1 Slope (%)	3.8		X Walk 2 Slope (%)	N/A
	X Walk 1 X Slope (%)	3.1		X Walk 2 X Slope (%)	N/A

Possible Solutions:

Remove & Replace Entire Ramp.
