Access Compliance Report

Public Rights-of-Way

(Curb Ramps)

Intersection ID: 21819	Main Street: AUTUMN_BLAZE_DR	Cross Street: POPLAR_FOREST_DR	Location: SW
ADA ID: 4EE8BCDC550E	Ramp Type: PerpDiag	Initial Pass/Fail: Fail	Overall Compliance: No
Severity Score: 35			
Codes/Mitigation Info/Possible Solution		Field Measurements/Component Compliance

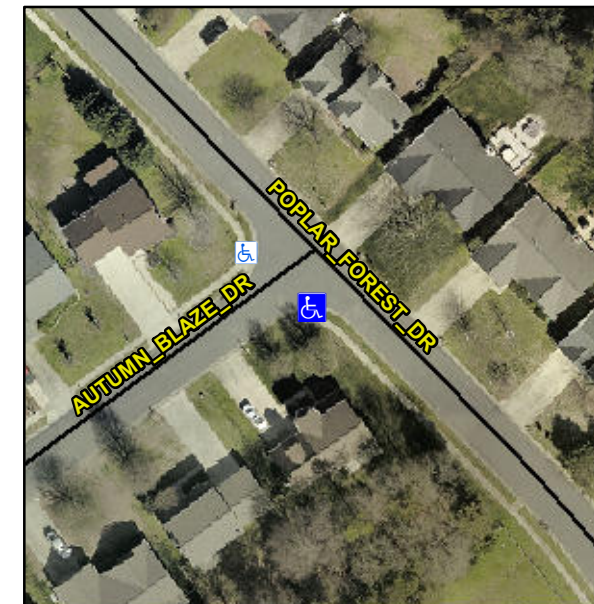
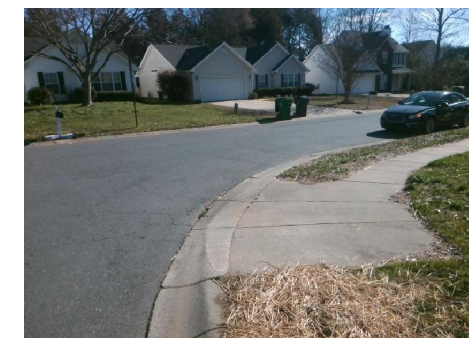
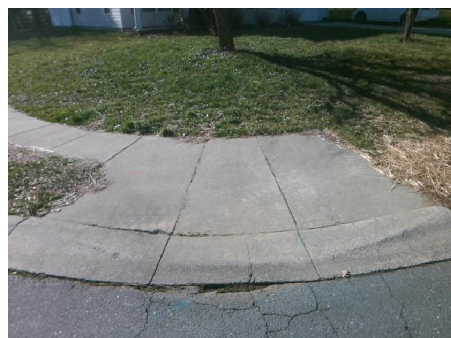
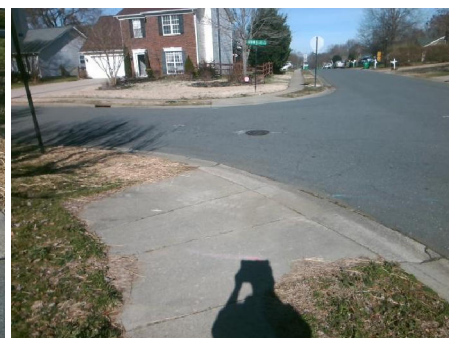
Compliance	Description	Data	Compliance	Description	Data
N/A	Ramp Length (in)	96.0	Yes	Ramp Slope (%)	6.1
No	Ramp Width (in)	30.5	Yes	Ramp XSlope (%)	0.5
N/A	Flare Type LT	N/A	N/A	Flare Type RT	N/A
N/A	Flare Slope LT (%)	N/A	N/A	Flare Slope RT (%)	N/A
N/A	Flare Traversable LT?	N/A	N/A	Flare Traversable RT?	N/A
N/A	Landing Length (in)	N/A	N/A	DWS Provided?	N/A
N/A	Landing Width (in)	N/A	N/A	DWS Contrast?	N/A
N/A	Landing Slope (%)	N/A	N/A	DWS Length (in)	N/A
N/A	Landing X Slope (%)	N/A	N/A	DWS Full Width?	N/A
N/A	Landing Curb? (Y/N)	N/A	N/A	DWS Offset (in)	N/A
N/A	Shared Landing?	N/A			
N/A	Gutter Ponding?	N/A	N/A	Gutter Slope (%)	N/A
N/A	Gutter Lip Ht (in)	1.5	N/A	Gutter X Slope (%)	N/A
N/A	Painted X Walk1?	No	N/A	Painted X Walk2?	No
	X Walk 1 Direction	To NE		X Walk 2 Direction	To NW
N/A	X Walk 1 Width (in)	N/A	N/A	X Walk 2 Width (in)	N/A
	X Walk 1 Slope (%)	1.5		X Walk 2 Slope (%)	3.3
	X Walk 1 X Slope (%)	0.7		X Walk 2 X Slope (%)	1.0

N/A	Ramp inside XWalk1?	N/A	N/A	Ramp inside XWalk2?	N/A
	Road Slope (%)	0.5	N/A	Clear Space?	N/A
	Road X Slope (%)	6.5	N/A	Clear Space to XWalk (in)	N/A
N/A	Any Obstructions?	N/A	N/A	Storm Grate/Utility Hazard?	N/A
	Obstruction Type			Storm Grate/Utility Type	
		N/A			N/A
		Yes		Surface Condition? (G/P)	Good

Possible Solutions:

Remove & Replace Curb Ramp With Two New Directional Ramps or Equivalent.

R304.5.1
