Access Compliance Report Public Rights-of-Way (Curb Ramps)

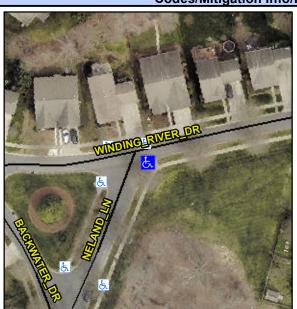
Intersection ID: 29985 Main Street: NELAND_LN Cross Street: WINDING_RIVER_DR Location: S **Overall Compliance: No ADA ID: 4EEC75B5BCDA** Ramp Type: Perp Initial Pass/Fail: Fail **Severity Score:** 25

Field Measurements/Component Compliance								
Comp	oliance Description	Data	Comp	liance Description	Data			
N/A	Ramp Length (in)	71.0	No	Ramp Slope (%)	9.1			
Yes	Ramp Width (in)	48.0	No	Ramp XSlope (%)	5.3			
N/A	Flare Type LT	N/A	N/A	Flare Type RT	N/A			
N/A	Flare Slope LT (%)	N/A	N/A	Flare Slope RT (%)	N/A			
N/A	Flare Traversable LT?	N/A	N/A	Flare Traversable RT?	N/A			
N/A	Landing Length (in)	N/A	N/A	DWS Provided?	N/A			
N/A	Landing Width (in)	N/A	N/A	DWS Contrast?	N/A			
N/A	Landing Slope (%)	N/A	N/A	DWS Length (in)	N/A			
N/A	Landing X Slope (%)	N/A	N/A	DWS Full Width?	N/A			
N/A	Landing Curb? (Y/N)	N/A	N/A	DWS Offset (in)	N/A			
N/A	Shared Landing?	N/A						
N/A	Gutter Ponding?	N/A	N/A	Gutter Slope (%)	N/A			
N/A	Gutter Lip Ht (in)	N/A	N/A	Gutter X Slope (%)	N/A			
N/A	Painted X Walk1?	No	N/A	Painted X Walk2?	N/A			
	X Walk 1 Direction	To N		X Walk 2 Direction	N/A			
N/A	X Walk 1 Width (in)	N/A	N/A	X Walk 2 Width (in)	N/A

X Walk 1 Slope (%)	0.2		X Walk 2 Slope (%)	N/A			
	X Walk 1 X Slope (%)	6.3		X Walk 2 X Slope (%)	N/A			
N/A	Ramp inside XWalk1?	N/A	N/A	Ramp inside XWalk2?	N/A			
	Road Slope (%)	N/A	N/A	Clear Space?	N/A			
	Road X Slope (%)	N/A	N/A	Clear Space to XWalk (in)	N/A			
N/A	Any Obstructions?	N/A	N/A	Storm Grate/Utility Hazard?	N/A			
	Obstruction Type			Storm Grate/Utility Type				
		N/A			N/A			
			Yes	Surface Condition? (G/P)	Good			
NA.

ossible Solutions:	<u>c</u>
Remove & Replace Entire Ramp.	
·	Υ
	N
	N
	N
	N
urveyor Notes:	N
N/A	N
	N
	N
	N
ROW/ADA:	N
Not Found, R304.2.2, R304.5.3	
	N
	N
	N

Total Cost:		\$ 1850.00
