# Access Compliance Report

## Public Rights-of-Way

### (Curb Ramps)

Intersection ID: 15178	Main Street: DILWORTH_RD_EAST	Cross Street: IDEAL_WY	Location: NW
ADA ID: 4EFB65C14BBD	Ramp Type: PerpDiag	Initial Pass/Fail: Fail	Overall Compliance: No
Severity Score: 12.5			
Codes/Mitigation Info/Possible Solution		Field Measurements/Component Compliance

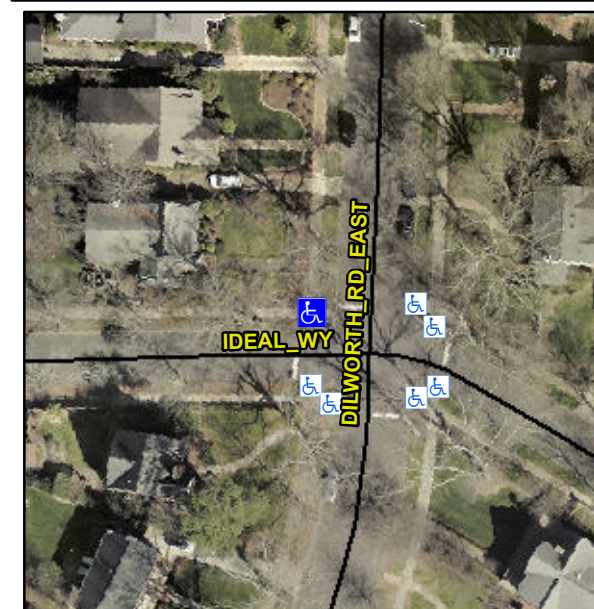
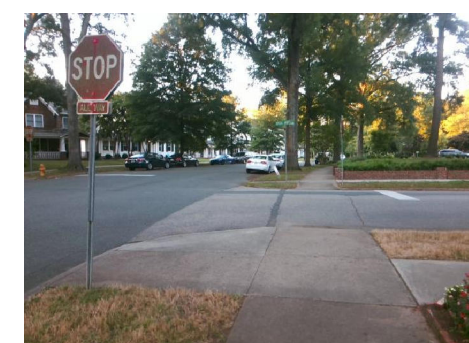
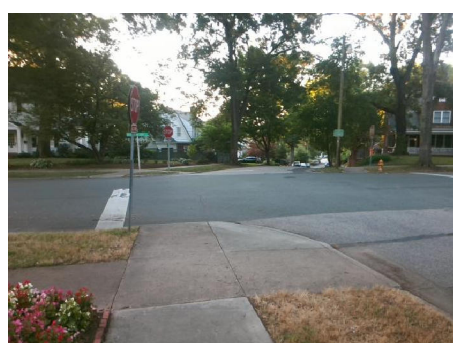
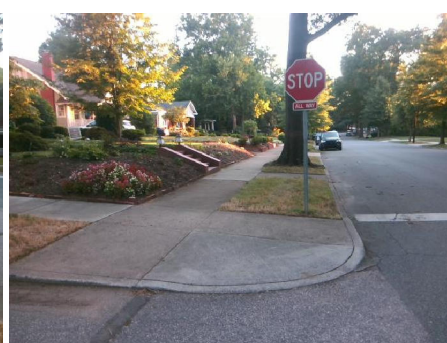
Compliance	Description	Data	Compliance	Description	Data
N/A	Ramp Length (in)	72.0	Yes	Ramp Slope (%)	6.9
Yes	Ramp Width (in)	72.0	No	Ramp XSlope (%)	5.5
N/A	Flare Type LT	N/A	N/A	Flare Type RT	N/A
N/A	Flare Slope LT (%)	N/A	N/A	Flare Slope RT (%)	N/A
N/A	Flare Traversable LT?	N/A	N/A	Flare Traversable RT?	N/A
N/A	Landing Length (in)	N/A	N/A	DWS Provided?	N/A
N/A	Landing Width (in)	N/A	N/A	DWS Contrast?	N/A
N/A	Landing Slope (%)	N/A	N/A	DWS Length (in)	N/A
N/A	Landing X Slope (%)	N/A	N/A	DWS Full Width?	N/A
N/A	Landing Curb? (Y/N)	N/A	N/A	DWS Offset (in)	N/A
N/A	Shared Landing?	N/A			
N/A	Gutter Ponding?	N/A	N/A	Gutter Slope (%)	N/A
N/A	Gutter Lip Ht (in)	N/A	N/A	Gutter X Slope (%)	N/A
N/A	Painted X Walk1?	No	N/A	Painted X Walk2?	No
	X Walk 1 Direction	To S		X Walk 2 Direction	To E
N/A	X Walk 1 Width (in)	N/A	N/A	X Walk 2 Width (in)	N/A
	X Walk 1 Slope (%)	3.8		X Walk 2 Slope (%)	3.7
	X Walk 1 X Slope (%)	0.7		X Walk 2 X Slope (%)	2.9

N/A	Ramp inside XWalk1?	N/A	N/A	Ramp inside XWalk2?	N/A
	Road Slope (%)	4.1	N/A	Clear Space?	N/A
	Road X Slope (%)	3.5	N/A	Clear Space to XWalk (in)	N/A
N/A	Any Obstructions?	N/A	N/A	Storm Grate/Utility Hazard?	N/A
	Obstruction Type			Storm Grate/Utility Type	
		N/A			N/A
		Yes		Surface Condition? (G/P)	Good

Possible Solutions:

**Remove & Replace Curb Ramp With Two New Directional Ramps or Equivalent.**

**Not Found, R304.5.3**

Total Cost: \$ 3200.00
