Access Compliance Report

Public Rights-of-Way

(Curb Ramps)

Intersection ID: 25536	Main Street: CARPENTER_DR	Cross Street: QUAIL_RIDGE_DR	Location: SE
ADA ID: 4EFBF9B5E3A0	Ramp Type: PerpDiag	Initial Pass/Fail: Fail	Overall Compliance: No
		Severity Score: 25

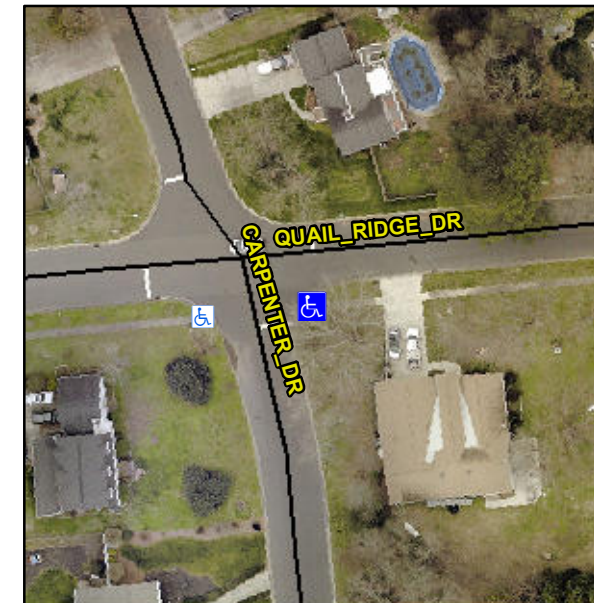
Not Found, R304.5.3

Compliance	Description	Data	Compliance	Description	Data
N/A	Ramp Length (in)	27.0	Yes	Ramp Slope (%)	6.5
Yes	Ramp Width (in)	50.0	No	Ramp XSlope (%)	13.4
N/A	Flare Type LT	N/A	N/A	Flare Type RT	N/A
N/A	Flare Slope LT (%)	N/A	N/A	Flare Slope RT (%)	N/A
N/A	Flare Traversable LT?	N/A	N/A	Flare Traversable RT?	N/A
N/A	Landing Length (in)	N/A	N/A	DWS Provided?	N/A
N/A	Landing Width (in)	N/A	N/A	DWS Contrast?	N/A
N/A	Landing Slope (%)	N/A	N/A	DWS Length (in)	N/A
N/A	Landing X Slope (%)	N/A	N/A	DWS Full Width?	N/A
N/A	Landing Curb? (Y/N)	N/A	N/A	DWS Offset (in)	N/A
N/A	Shared Landing?	N/A			
N/A	Gutter Ponding?	N/A	N/A	Gutter Slope (%)	N/A
N/A	Gutter Lip Ht (in)	N/A	N/A	Gutter X Slope (%)	N/A
N/A	Painted X Walk1?	No	N/A	Painted X Walk2?	No
	X Walk 1 Direction	To N		X Walk 2 Direction	To W
N/A	X Walk 1 Width (in)	N/A	N/A	X Walk 2 Width (in)	N/A
	X Walk 1 Slope (%)	4.3		X Walk 2 Slope (%)	10.8
	X Walk 1 X Slope (%)	12.4		X Walk 2 X Slope (%)	2.3

N/A	Ramp inside XWalk1?	N/A	N/A	Ramp inside XWalk2?	N/A
	Road Slope (%)	11.9	N/A	Clear Space?	N/A
	Road X Slope (%)	4.5	N/A	Clear Space to XWalk (in)	N/A
N/A	Any Obstructions?	N/A	N/A	Storm Grate/Utility Hazard?	N/A
	Obstruction Type			Storm Grate/Utility Type	
		N/A			N/A
		Yes		Surface Condition? (G/P)	Good

Remove & Replace Curb Ramp With Two New Directional Ramps or Equivalent.

Total Cost: \$ 3200.00
