Access Compliance Report

Public Rights-of-Way

(Curb Ramps)

Intersection ID: 17247	Main Street: RANDOLPH_RD	Cross Street: S_CANTERBURY_RD	Location: S
ADA ID: 4F151A28C4B1	Ramp Type: PerpDiag	Initial Pass/Fail: Fail	Overall Compliance: No
		Severity Score: 22.5

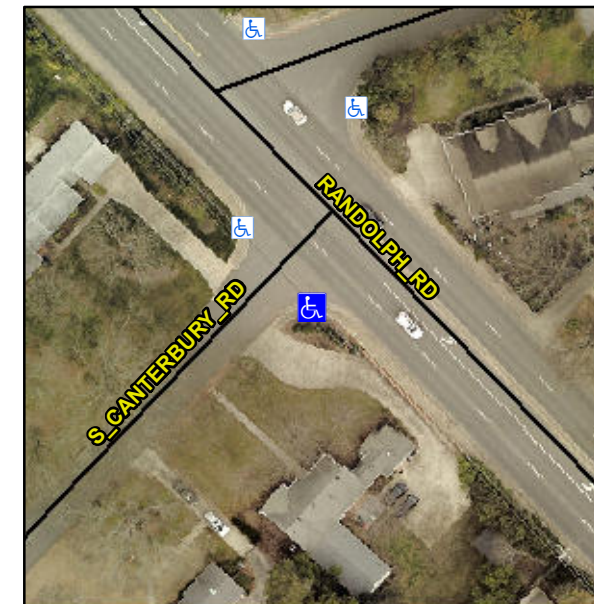
Compliance	Description	Data	Compliance	Description	Data
N/A	Ramp Length (in)	49.0	No	Ramp Slope (%)	11.9
No	Ramp Width (in)	46.0	No	Ramp XSlope (%)	2.8
N/A	Flare Type LT	N/A	N/A	Flare Type RT	N/A
N/A	Flare Slope LT (%)	N/A	N/A	Flare Slope RT (%)	N/A
N/A	Flare Traversable LT?	N/A	N/A	Flare Traversable RT?	N/A
N/A	Landing Length (in)	N/A	N/A	DWS Provided?	N/A
N/A	Landing Width (in)	N/A	N/A	DWS Contrast?	N/A
N/A	Landing Slope (%)	N/A	N/A	DWS Length (in)	N/A
N/A	Landing X Slope (%)	N/A	N/A	DWS Full Width?	N/A
N/A	Landing Curb? (Y/N)	N/A	N/A	DWS Offset (in)	N/A
N/A	Shared Landing?	N/A			
N/A	Gutter Ponding?	N/A	N/A	Gutter Slope (%)	N/A
N/A	Gutter Lip Ht (in)	N/A	N/A	Gutter X Slope (%)	N/A
N/A	Painted X Walk1?	No	N/A	Painted X Walk2?	No
	X Walk 1 Direction	To NE		X Walk 2 Direction	To NW
N/A	X Walk 1 Width (in)	N/A	N/A	X Walk 2 Width (in)	N/A
	X Walk 1 Slope (%)	0.7		X Walk 2 Slope (%)	2.4
	X Walk 1 X Slope (%)	2.6		X Walk 2 X Slope (%)	1.7

N/A	Ramp inside XWalk1?	N/A	N/A	Ramp inside XWalk2?	N/A
	Road Slope (%)	0.1	N/A	Clear Space?	N/A
	Road X Slope (%)	5.8	N/A	Clear Space to XWalk (in)	N/A
N/A	Any Obstructions?	N/A	N/A	Storm Grate/Utility Hazard?	N/A
	Obstruction Type			Storm Grate/Utility Type	
		N/A			N/A
			Yes	Surface Condition? (G/P)	Good

Remove & Replace Curb Ramp With Two New Directional Ramps or Equivalent.
