Access Compliance Report

Public Rights-of-Way

(Curb Ramps)

Intersection ID: 15013	Main Street: E_WORTHINGTON_AV	Cross Street: EWING_AV	Location: SE
ADA ID: 4F192308FAC8	Ramp Type: Perp	Initial Pass/Fail: Fail	Overall Compliance: No
Codes/Mitigation Info/Possible Solution			Severity Score: 30
			Field Measurements/Component Compliance

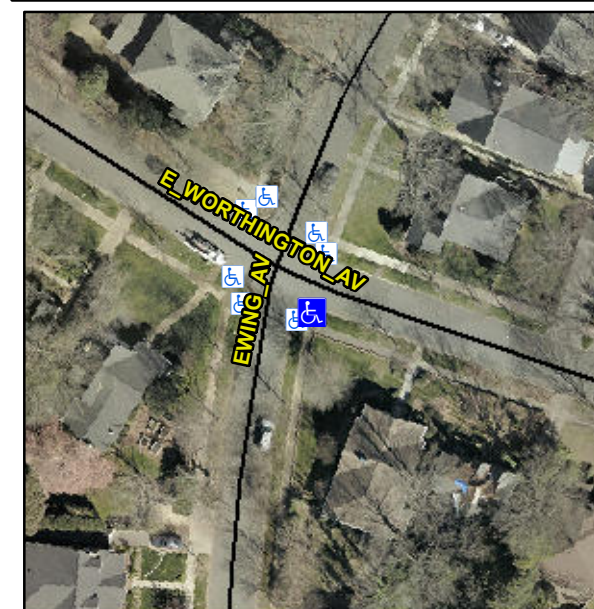
Not Found, R304.5.1, R304.2.2

Compliance	Description	Data	Compliance	Description	Data
N/A	Ramp Length (in)	78.0	No	Ramp Slope (%)	8.9
No	Ramp Width (in)	32.0	Yes	Ramp XSlope (%)	0.4
N/A	Flare Type LT	N/A	N/A	Flare Type RT	N/A
N/A	Flare Slope LT (%)	N/A	N/A	Flare Slope RT (%)	N/A
N/A	Flare Traversable LT?	N/A	N/A	Flare Traversable RT?	N/A
N/A	Landing Length (in)	N/A	N/A	DWS Provided?	N/A
N/A	Landing Width (in)	N/A	N/A	DWS Contrast?	N/A
N/A	Landing Slope (%)	N/A	N/A	DWS Length (in)	N/A
N/A	Landing X Slope (%)	N/A	N/A	DWS Full Width?	N/A
N/A	Landing Curb? (Y/N)	N/A	N/A	DWS Offset (in)	N/A
N/A	Shared Landing?	N/A			
N/A	Gutter Ponding?	Yes	N/A	Gutter Slope (%)	N/A
N/A	Gutter Lip Ht (in)	N/A	N/A	Gutter X Slope (%)	N/A
N/A	Painted X Walk1?	No	N/A	Painted X Walk2?	N/A
	X Walk 1 Direction	To NE		X Walk 2 Direction	N/A
N/A	X Walk 1 Width (in)	N/A	N/A	X Walk 2 Width (in)	N/A
	X Walk 1 Slope (%)	4.3		X Walk 2 Slope (%)	N/A
	X Walk 1 X Slope (%)	2.1		X Walk 2 X Slope (%)	N/A

N/A	Ramp inside XWalk1?	N/A	N/A	Ramp inside XWalk2?	N/A
	Road Slope (%)	N/A	N/A	Clear Space?	N/A
	Road X Slope (%)	N/A	N/A	Clear Space to XWalk (in)	N/A
N/A	Any Obstructions?	N/A	N/A	Storm Grate/Utility Hazard?	N/A
	Obstruction Type			Storm Grate/Utility Type	
		N/A			N/A
			Yes	Surface Condition? (G/P)	Good

Possible Solutions:

Remove & Replace Entire Ramp.
