# Access Compliance Report

## Public Rights-of-Way

### (Curb Ramps)

Intersection ID: 46308	Main Street: DONNEGAL_FARM_RD	Cross Street: BECKET RIDGE_RD	Location: NW
ADA ID: 4F1DBE402749	Ramp Type: PerpDiag	Initial Pass/Fail: Fail	Overall Compliance: No
Severity Score: 10			
Codes/Mitigation Info/Possible Solution		Field Measurements/Component Compliance

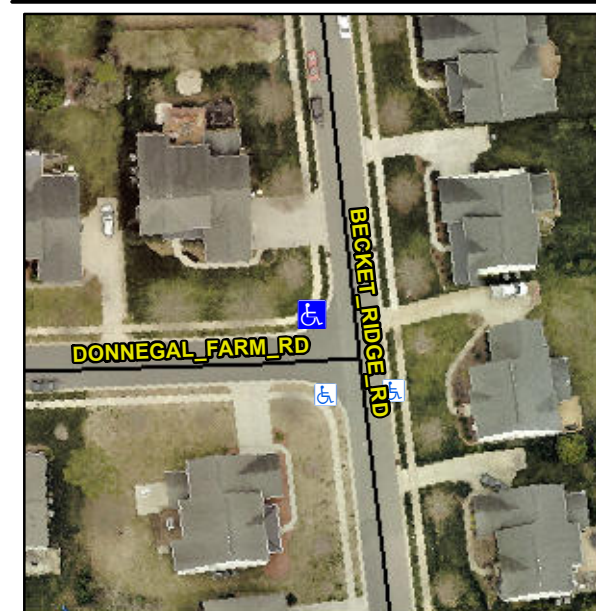
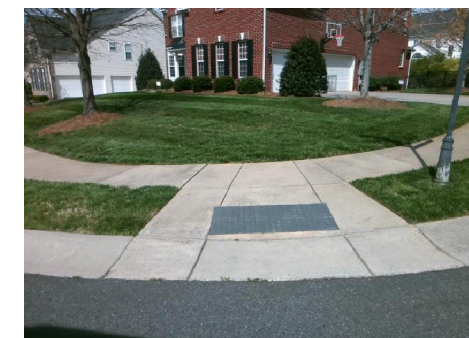
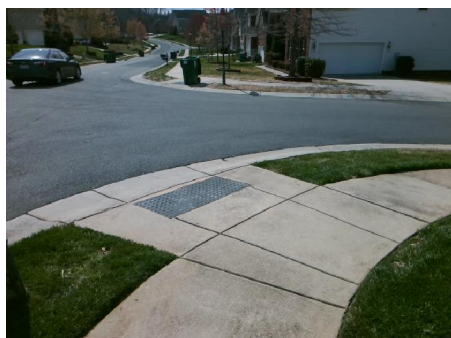
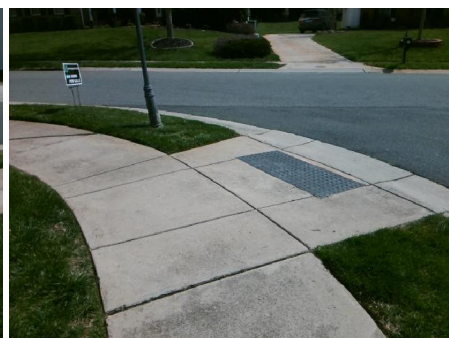
**Not Found, R304.5.1, R304.5.3**

Compliance	Description	Data	Compliance	Description	Data
N/A	Ramp Length (in)	51.0	Yes	Ramp Slope (%)	8.0
No	Ramp Width (in)	40.5	No	Ramp XSlope (%)	4.5
N/A	Flare Type LT	N/A	N/A	Flare Type RT	N/A
N/A	Flare Slope LT (%)	N/A	N/A	Flare Slope RT (%)	N/A
N/A	Flare Traversable LT?	N/A	N/A	Flare Traversable RT?	N/A
N/A	Landing Length (in)	N/A	N/A	DWS Provided?	N/A
N/A	Landing Width (in)	N/A	N/A	DWS Contrast?	N/A
N/A	Landing Slope (%)	N/A	N/A	DWS Length (in)	N/A
N/A	Landing X Slope (%)	N/A	N/A	DWS Full Width?	N/A
N/A	Landing Curb? (Y/N)	N/A	N/A	DWS Offset (in)	N/A
N/A	Shared Landing?	N/A			
N/A	Gutter Ponding?	N/A	N/A	Gutter Slope (%)	N/A
N/A	Gutter Lip Ht (in)	N/A	N/A	Gutter X Slope (%)	N/A
N/A	Painted X Walk1?	No	N/A	Painted X Walk2?	No
	X Walk 1 Direction	To S		X Walk 2 Direction	To E
N/A	X Walk 1 Width (in)	N/A	N/A	X Walk 2 Width (in)	N/A
	X Walk 1 Slope (%)	3.0		X Walk 2 Slope (%)	1.5
	X Walk 1 X Slope (%)	3.2		X Walk 2 X Slope (%)	2.0

N/A	Ramp inside XWalk1?	N/A	N/A	Ramp inside XWalk2?	N/A
	Road Slope (%)	5.5	N/A	Clear Space?	N/A
	Road X Slope (%)	0.0	N/A	Clear Space to XWalk (in)	N/A
N/A	Any Obstructions?	N/A	N/A	Storm Grate/Utility Hazard?	N/A
	Obstruction Type			Storm Grate/Utility Type	
		N/A			N/A
			Yes	Surface Condition? (G/P)	Good

**Remove & Replace Curb Ramp With Two New Directional Ramps or Equivalent.**
