Access Compliance Report

Public Rights-of-Way

(Curb Ramps)

Intersection ID: 3794	Main Street: DEER_CROSS_TL	Cross Street: LAUREL_RIDGE_TL	Location:	N
ADA ID: 4F21C23FF6F8	Ramp Type: BlendTrans1	Initial Pass/Fail: Fail	Overall Compliance: No	Severity Score: 8.75

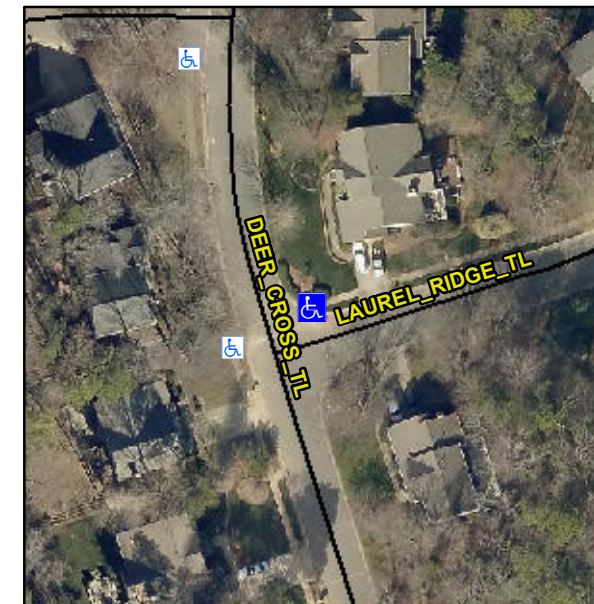
BUSHES GROWING OVER RAMP & SIDEWALK

Not Found, R304.5.1

Compliance	Description	Data	Compliance	Description	Data
N/A	Ramp Length (in)	70.0	Yes	BlendTrans Slope (%)	3.7
No	Ramp Width (in)	43.0	Yes	BlendTrans XSlope (%)	1.2
N/A	Flare Type LT	N/A	N/A	Flare Type RT	N/A
N/A	Flare Slope LT (%)	N/A	N/A	Flare Slope RT (%)	N/A
N/A	Flare Traversable LT?	N/A	N/A	Flare Traversable RT?	N/A
N/A	Landing Length (in)	N/A	N/A	DWS Provided?	N/A
N/A	Landing Width (in)	N/A	N/A	DWS Contrast?	N/A
N/A	Landing Slope (%)	N/A	N/A	DWS Length (in)	N/A
N/A	Landing X Slope (%)	N/A	N/A	DWS Full Width?	N/A
N/A	Landing Curb? (Y/N)	N/A	N/A	DWS Offset (in)	N/A
N/A	Shared Landing?	N/A			
N/A	Gutter Ponding?	N/A	N/A	Gutter Slope (%)	N/A
N/A	Gutter Lip Ht (in)	N/A	N/A	Gutter X Slope (%)	N/A
N/A	Painted X Walk1?	No	N/A	Painted X Walk2?	N/A
	X Walk 1 Direction	To SW		X Walk 2 Direction	N/A
	X Walk 1 Width (in)	N/A		X Walk 2 Width (in)	N/A
	X Walk 1 Slope (%)	3.9		X Walk 2 Slope (%)	N/A
	X Walk 1 X Slope (%)	6.6		X Walk 2 X Slope (%)	N/A

N/A	Ramp inside XWalk1?	N/A	N/A	Ramp inside XWalk2?	N/A
	Road Slope (%)	6.6		Clear Space?	N/A
	Road X Slope (%)	3.9	N/A	Clear Space to XWalk (in)	N/A
N/A	Any Obstructions?	N/A	N/A	Storm Grate/Utility Hazard?	N/A
	Obstruction Type			Storm Grate/Utility Type	
		N/A			N/A
			Yes	Surface Condition? (G/P)	Good
			No	Curb Slope (%)	9.4

Remove & Replace Curb Ramp With Two New Directional Ramps or Equivalent.
